HOME REPORT

1 HIGH STREET
PORTNAHAVEN
ISLE OF ISLAY
PA47 7SN

Energy Performance Certificate (EPC)

Dwelling type: Detached bungalow
Date of assessment: 23 April 2024
Date of certificate: 07 May 2024
Total floor area: 50 m²
Primary Energy Indicator: 409 kWh/m²/year

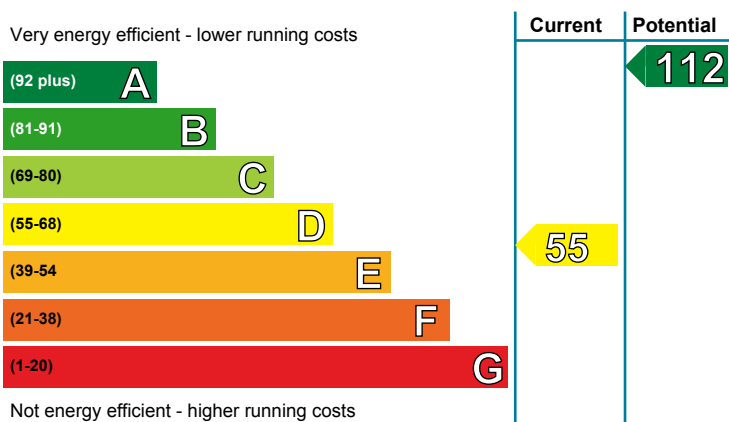
Energy Efficiency Rating

This graph shows the current efficiency of your home, taking into account both energy efficiency and fuel costs. The higher this rating, the lower your fuel bills are likely to be.

Your current rating is **band D (55)**. The average rating for EPCs in Scotland is **band D (61)**.

The potential rating shows the effect of undertaking all of the improvement measures listed within your recommendations report.

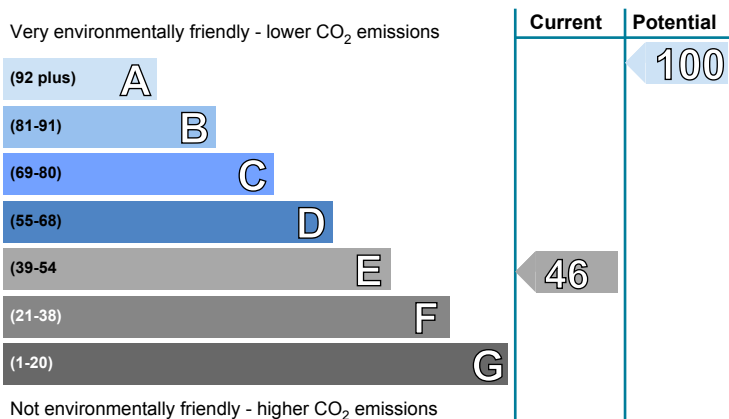
Environmental Impact (CO₂) Rating

This graph shows the effect of your home on the environment in terms of carbon dioxide (CO₂) emissions. The higher the rating, the less impact it has on the environment.

Your current rating is **band E (46)**. The average rating for EPCs in Scotland is **band D (59)**.

The potential rating shows the effect of undertaking all of the improvement measures listed within your recommendations report.

The average Scottish household produces about 6 tonnes of carbon dioxide every year. Based on this assessment, heating and lighting this home currently produces approximately 4.4 tonnes of carbon dioxide every year. Adopting recommendations in this report can reduce emissions and protect the environment. If you were to install all of these recommendations this could reduce emissions by 3.9 tonnes per year. You could reduce emissions even more by switching to renewable energy sources.
