HOME REPORT

INVERSHUNA MANSE BRAE

LOCHGILPHEAD
PA31 8QZ

Energy Performance Certificate (EPC)

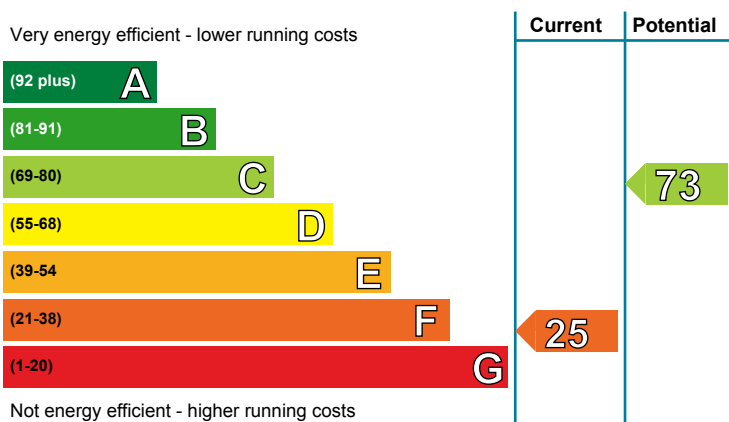
Energy Efficiency Rating

This graph shows the current efficiency of your home, taking into account both energy efficiency and fuel costs. The higher this rating, the lower your fuel bills are likely to be.

Your current rating is **band F (25)**. The average rating for EPCs in Scotland is **band D (61)**.

The potential rating shows the effect of undertaking all of the improvement measures listed within your recommendations report.

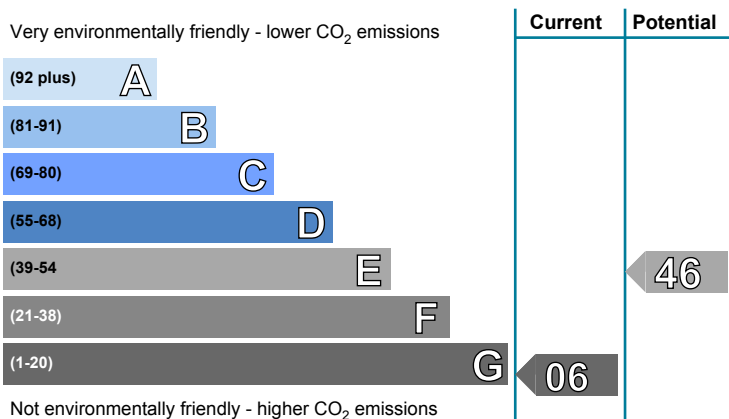
Environmental Impact (CO₂) Rating

This graph shows the effect of your home on the environment in terms of carbon dioxide (CO₂) emissions. The higher the rating, the less impact it has on the environment.

Your current rating is **band G (6)**. The average rating for EPCs in Scotland is **band D (59)**.

The potential rating shows the effect of undertaking all of the improvement measures listed within your recommendations report.
