# home report

**THE OLD STABLE FURNACE**

**INVERARAY  
PA32 8XN**

# Energy Performance Certificate (EPC)

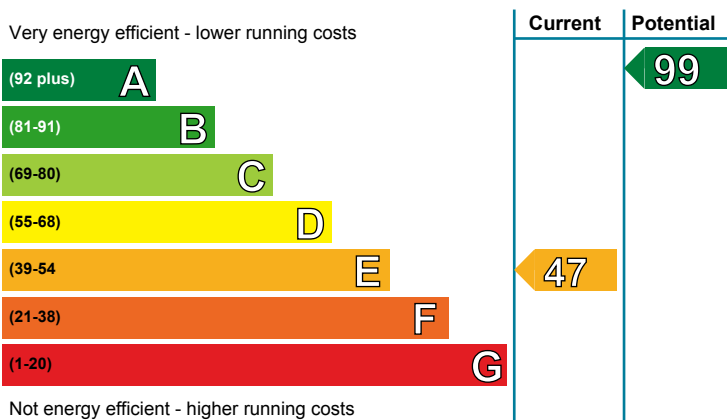
### Energy Efficiency Rating

This graph shows the current efficiency of your home, taking into account both energy efficiency and fuel costs. The higher this rating, the lower your fuel bills are likely to be.

Your current rating is **band E (47)**. The average rating for EPCs in Scotland is **band D (61)**.

The potential rating shows the effect of undertaking all of the improvement measures listed within your recommendations report.
