HOME REPORT

1 MAIN STREET
PORT CHARLOTTE
ISLE OF ISLAY
PA48 7TX

Energy Performance Certificate (EPC)

1 MAIN STREET, PORT CHARLOTTE, ISLE OF ISLAY, PA48 7TX

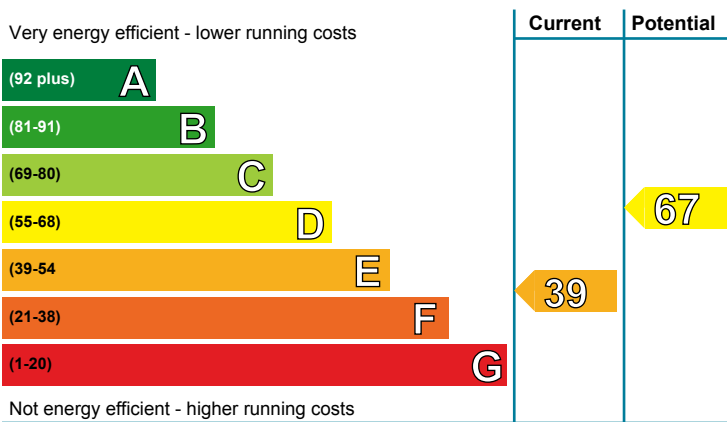
Energy Efficiency Rating

This graph shows the current efficiency of your home, taking into account both energy efficiency and fuel costs. The higher this rating, the lower your fuel bills are likely to be.

Your current rating is **band E (39)**. The average rating for EPCs in Scotland is **band D (61)**.

The potential rating shows the effect of undertaking all of the improvement measures listed within your recommendations report.

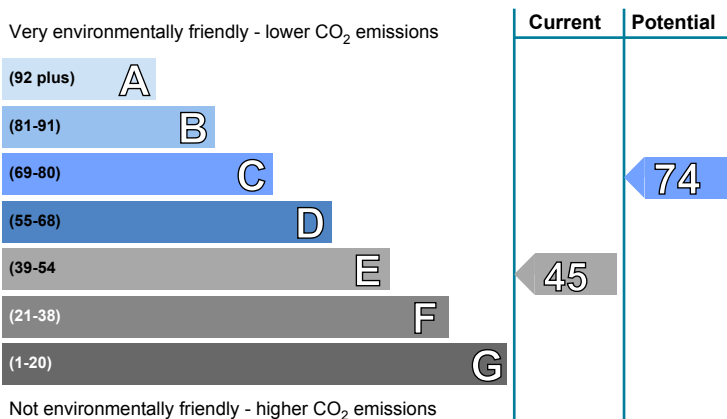
Environmental Impact (CO₂) Rating

This graph shows the effect of your home on the environment in terms of carbon dioxide (CO₂) emissions. The higher the rating, the less impact it has on the environment.

Your current rating is **band E (45)**. The average rating for EPCs in Scotland is **band D (59)**.

The potential rating shows the effect of undertaking all of the improvement measures listed within your recommendations report.
