# HOME REPORT

FLAT  
2/2 CLYDESDALE BUILDINGS  
ARGYLL STREET  
LOCHGILPHEAD  
PA31 8NE

# Single Survey

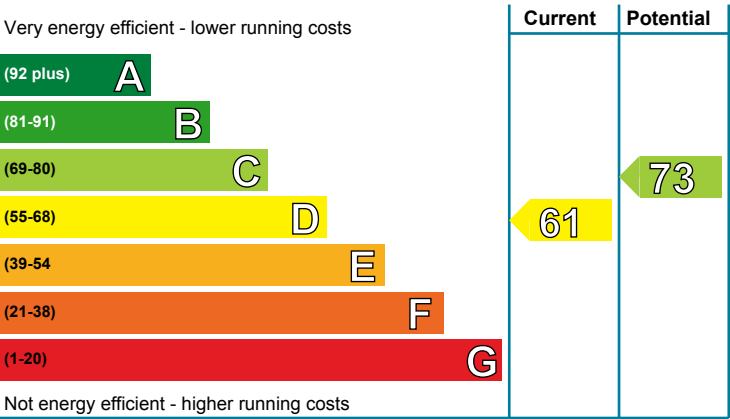
### Energy Efficiency Rating

This graph shows the current efficiency of your home, taking into account both energy efficiency and fuel costs. The higher this rating, the lower your fuel bills are likely to be.

Your current rating is **band D (61)**. The average rating for EPCs in Scotland is **band D (61)**.

The potential rating shows the effect of undertaking all of the improvement measures listed within your recommendations report.

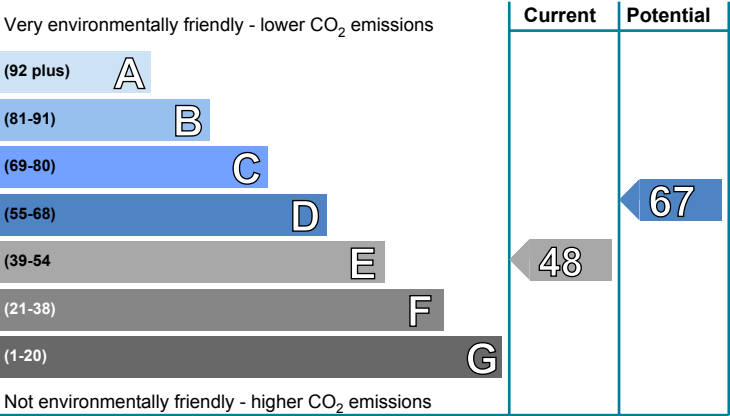
### Environmental Impact (CO<sub>2</sub>) Rating

This graph shows the effect of your home on the environment in terms of carbon dioxide (CO<sub>2</sub>) emissions. The higher the rating, the less impact it has on the environment.

Your current rating is **band E (48)**. The average rating for EPCs in Scotland is **band D (59)**.

The potential rating shows the effect of undertaking all of the improvement measures listed within your recommendations report.
