HOME REPORT

CRUBASDALE COTTAGE MUASDALE

TARBERT
PA29 6XD

Single Survey

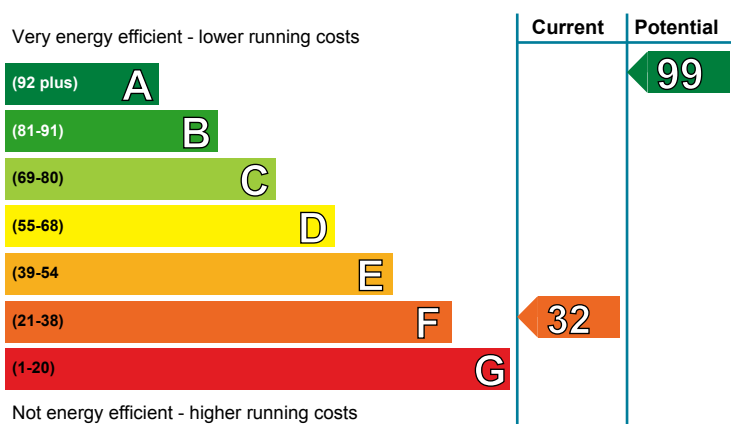
Energy Efficiency Rating

This graph shows the current efficiency of your home, taking into account both energy efficiency and fuel costs. The higher this rating, the lower your fuel bills are likely to be.

Your current rating is **band F (32)**. The average rating for EPCs in Scotland is **band D (61)**.

The potential rating shows the effect of undertaking all of the improvement measures listed within your recommendations report.

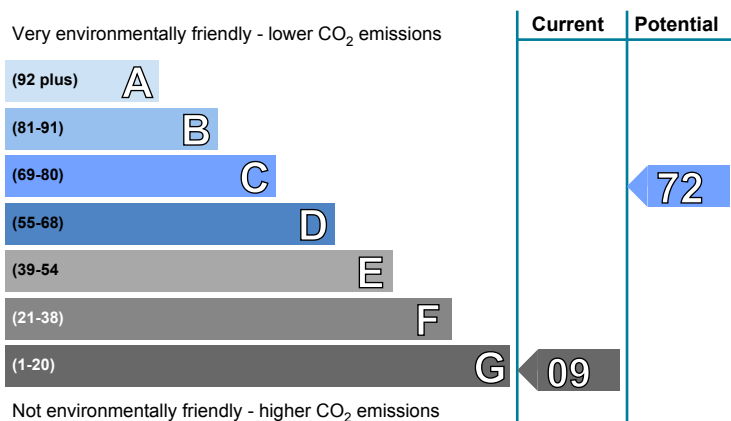
Environmental Impact (CO₂) Rating

This graph shows the effect of your home on the environment in terms of carbon dioxide (CO₂) emissions. The higher the rating, the less impact it has on the environment.

Your current rating is **band G (9)**. The average rating for EPCs in Scotland is **band D (59)**.

The potential rating shows the effect of undertaking all of the improvement measures listed within your recommendations report.
