10 Shore Street,
Portnahaven,
Isle of Islay,
PA47 7SH

Home Report

Single Survey

Property Address	10 Shore Street, Portnahaven, Isle of Islay, PA47 7SH
Reference	1029349
Customer Name	Josephine King
Date of Inspection	22nd April 2025
Surveyor's name, qualifications and office	Steven Graham BSc MRICS DM Hall LLP Chartered Surveyors The Oban Times Building Corran Esplanade Oban PA34 5PX Tel: 01631 564225 email: obanresidential@dmhall.co.uk
Prepared By	DM Hall LLP

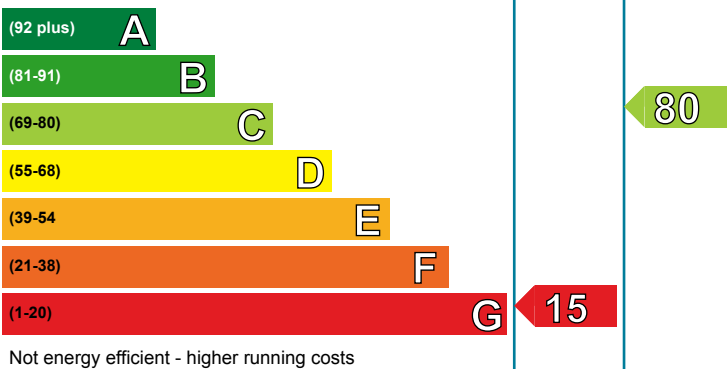
Energy Efficiency Rating

Very energy efficient - lower running costs

Not energy efficient - higher running costs

The potential rating shows the effect of undertaking all of the improvement measures listed within your recommendations report.

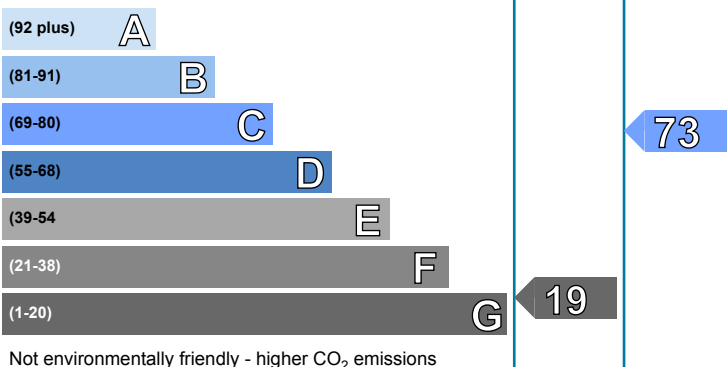
Environmental Impact (CO₂) Rating

Very environmentally friendly - lower CO₂ emissions

Not environmentally friendly - higher CO₂ emissions
