Cairnsmore,
Manse Brae,
Lochgilphead,
Argyll,
PA31 8QZ

Home Report

Single Survey

Property Address	Cairnsmore, Manse Brae, Lochgilphead, Argyll, PA31 8QZ
Reference	1197074
Customer Name	Catherine Moran
Date of Inspection	22nd August 2025
Surveyor's name, qualifications and office	Gary Duff DM Hall LLP Chartered Surveyors The Oban Times Building Corran Esplanade Oban PA34 5PX Tel: 01631 564225 email: obanresidential@dmhall.co.uk
Prepared By	DM Hall LLP

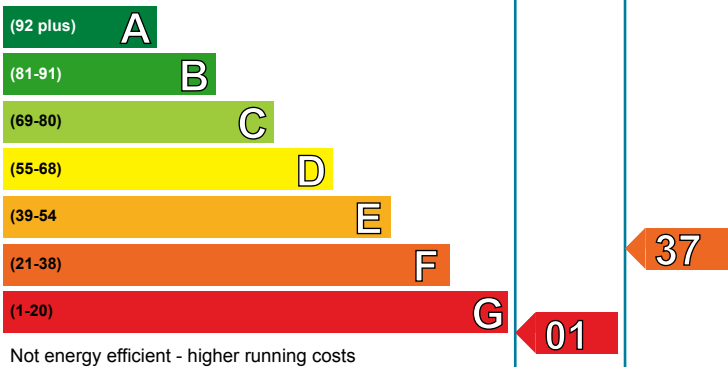
Energy Efficiency Rating

This graph shows the current efficiency of your home, taking into account both energy efficiency and fuel costs. The higher this rating, the lower your fuel bills are likely to be.

The potential rating shows the effect of undertaking all of the improvement measures listed within your recommendations report.

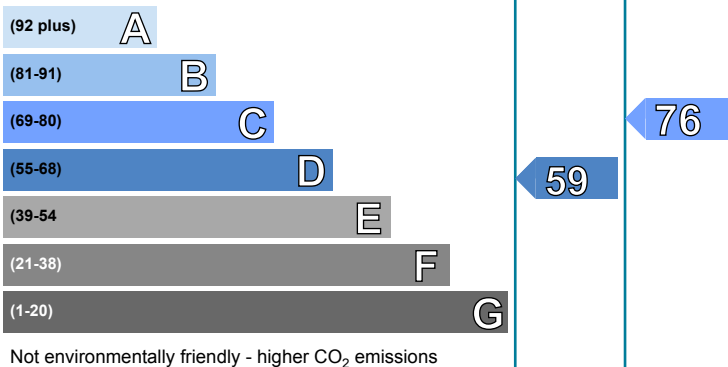
Environmental Impact (CO₂) Rating

This graph shows the effect of your home on the environment in terms of carbon dioxide (CO₂) emissions. The higher the rating, the less impact it has on the environment.
