HOME REPORT

5 SELKIRK AVENUE
PAISLEY
PA2 9JF

ENERGY REPORT

Energy Performance Certificate (EPC)

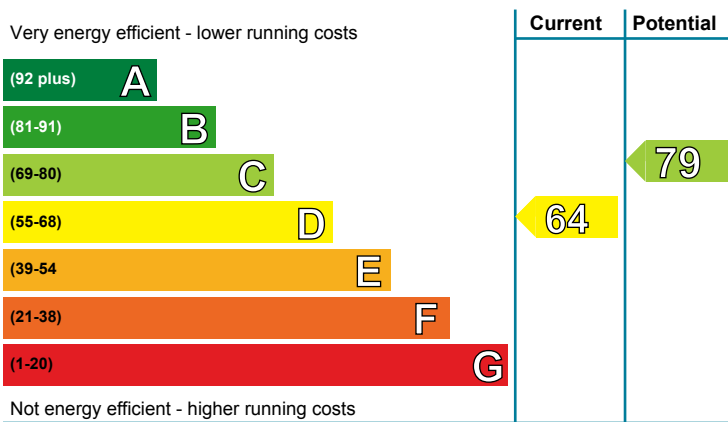
Energy Efficiency Rating

This graph shows the current efficiency of your home, taking into account both energy efficiency and fuel costs. The higher this rating, the lower your fuel bills are likely to be.

Your current rating is **band D (64)**. The average rating for EPCs in Scotland is **band D (61)**.

The potential rating shows the effect of undertaking all of the improvement measures listed within your recommendations report.

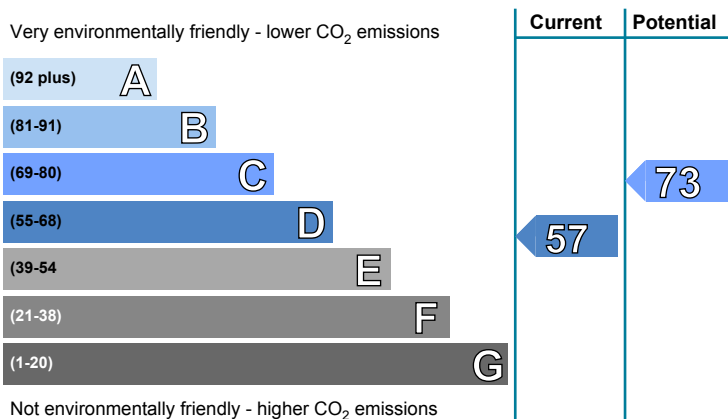
Environmental Impact (CO₂) Rating

This graph shows the effect of your home on the environment in terms of carbon dioxide (CO₂) emissions. The higher the rating, the less impact it has on the environment.

Your current rating is **band D (57)**. The average rating for EPCs in Scotland is **band D (59)**.

The potential rating shows the effect of undertaking all of the improvement measures listed within your recommendations report.
