Home Report

Scottish Single Survey

Property address	4 Woodpark Woodside Avenue Grantown-on-Spey PH26 3JR
Customer	Victoria Louise Mehrabi
Customer address	4 Woodpark Woodside Avenue Grantown-on-Spey PH26 3JR
Prepared by	Shepherd Chartered Surveyors
Date of inspection	06/06/2024

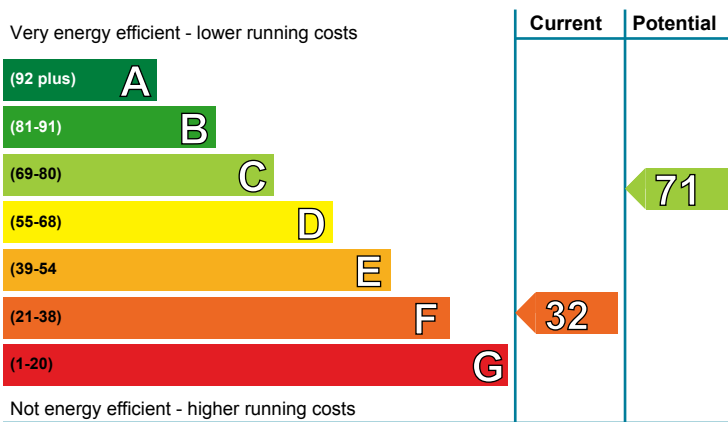
Energy Efficiency Rating

This graph shows the current efficiency of your home, taking into account both energy efficiency and fuel costs. The higher this rating, the lower your fuel bills are likely to be.

Your current rating is **band F (32)**. The average rating for EPCs in Scotland is **band D (61)**.

The potential rating shows the effect of undertaking all of the improvement measures listed within your recommendations report.

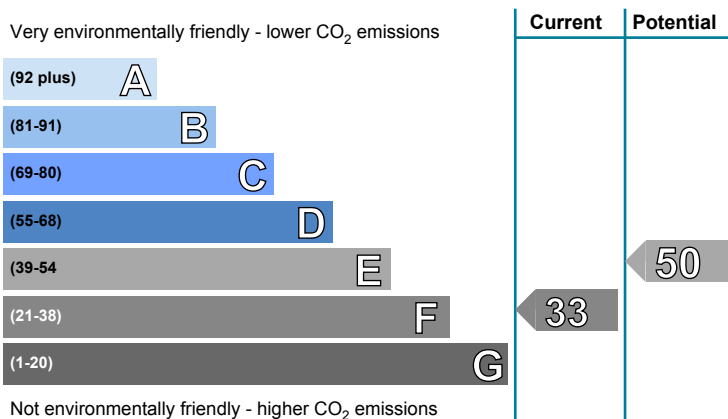
Environmental Impact (CO₂) Rating

This graph shows the effect of your home on the environment in terms of carbon dioxide (CO₂) emissions. The higher the rating, the less impact it has on the environment.
