YOUR ONESURVEY HOME REPORT

2 Dunbarry Terrace
Kingussie
PH21 1LL

SINGLE SURVEY

ENERGY REPORT

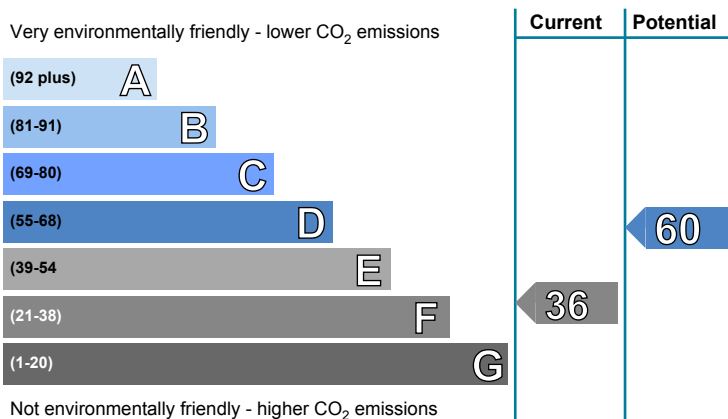
Environmental Impact (CO₂) Rating

This graph shows the effect of your home on the environment in terms of carbon dioxide (CO₂) emissions. The higher the rating, the less impact it has on the environment.
