Home Report

0/1 301,
Glasgow Harbour Terraces,
GLASGOW,
G11 6BP

Single Survey

Survey Report on:

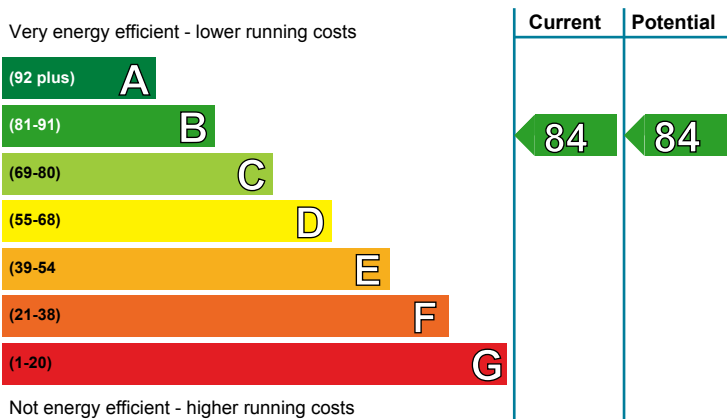
Energy Efficiency Rating

This graph shows the current efficiency of your home, taking into account both energy efficiency and fuel costs. The higher this rating, the lower your fuel bills are likely to be.

Your current rating is **band B (84)**. The average rating for EPCs in Scotland is **band D (61)**.

The potential rating shows the effect of undertaking all of the improvement measures listed within your recommendations report.

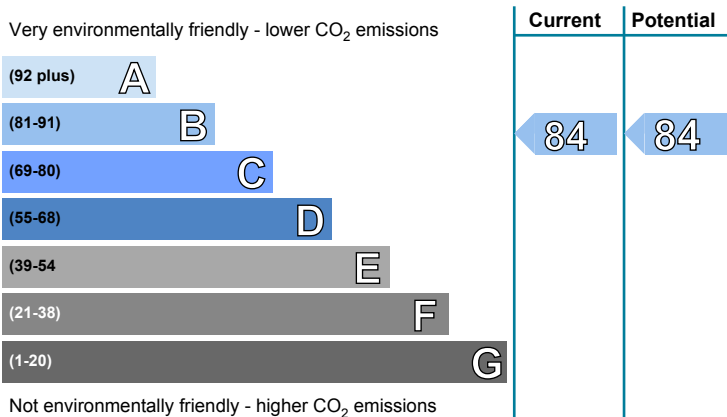
Environmental Impact (CO₂) Rating

This graph shows the effect of your home on the environment in terms of carbon dioxide (CO₂) emissions. The higher the rating, the less impact it has on the environment.
