3 Tokavaig,
Teangue,
Isle of Skye,
IV44 8QL

Home Report

Single Survey

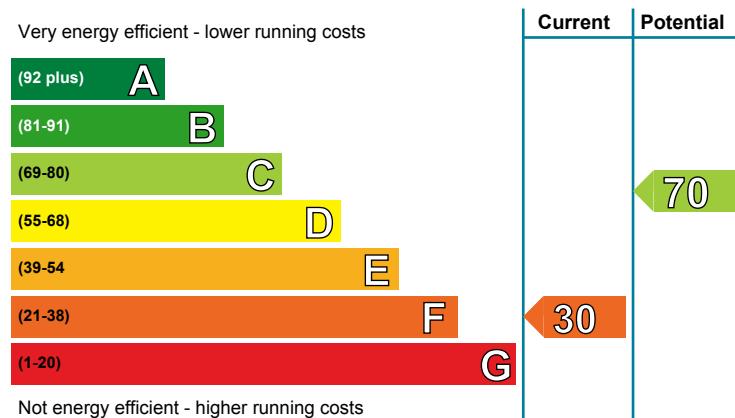
Energy Efficiency Rating

This graph shows the current efficiency of your home, taking into account both energy efficiency and fuel costs. The higher this rating, the lower your fuel bills are likely to be.

Your current rating is **band F (30)**. The average rating for EPCs in Scotland is **band D (61)**.

The potential rating shows the effect of undertaking all of the improvement measures listed within your recommendations report.

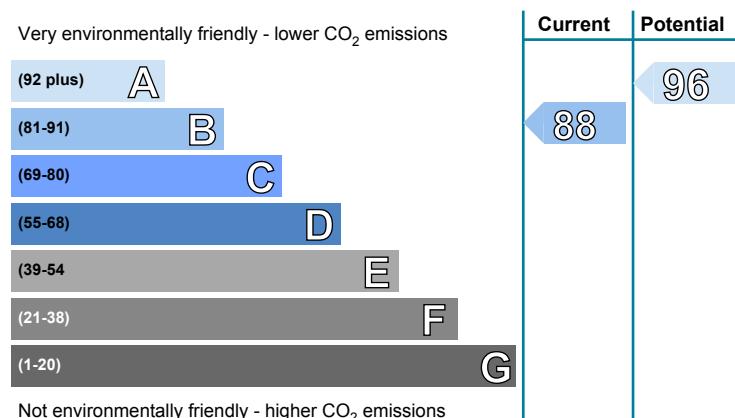
Environmental Impact (CO₂) Rating

This graph shows the effect of your home on the environment in terms of carbon dioxide (CO₂) emissions. The higher the rating, the less impact it has on the environment.
