YOUR ONESURVEY  
**HOME REPORT**

19a Bellevue Crescent  
Edinburgh  
EH3 6NF

# SINGLE SURVEY

A report on the condition of the property, with categories  
being rated from 1 to 3.

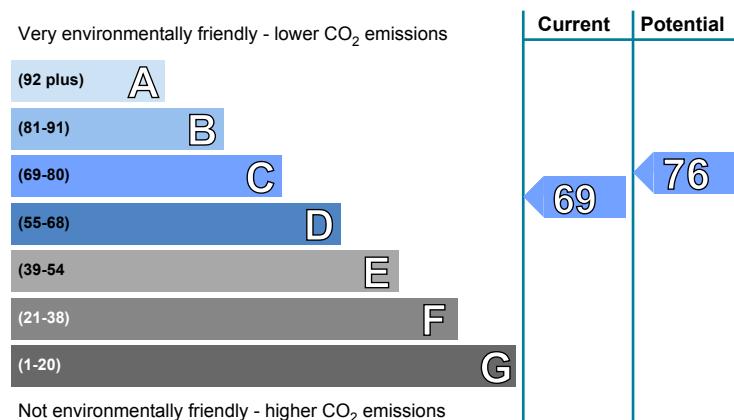
## Environmental Impact (CO<sub>2</sub>) Rating

This graph shows the effect of your home on the environment in terms of carbon dioxide (CO<sub>2</sub>) emissions. The higher the rating, the less impact it has on the environment.
