# Home Report

# Single Survey

## Survey Report on:

| <b>Property Address</b> | 16 Main Street,<br>Kirkcowan,<br>NEWTON STEWART,<br>DG8 0HG |

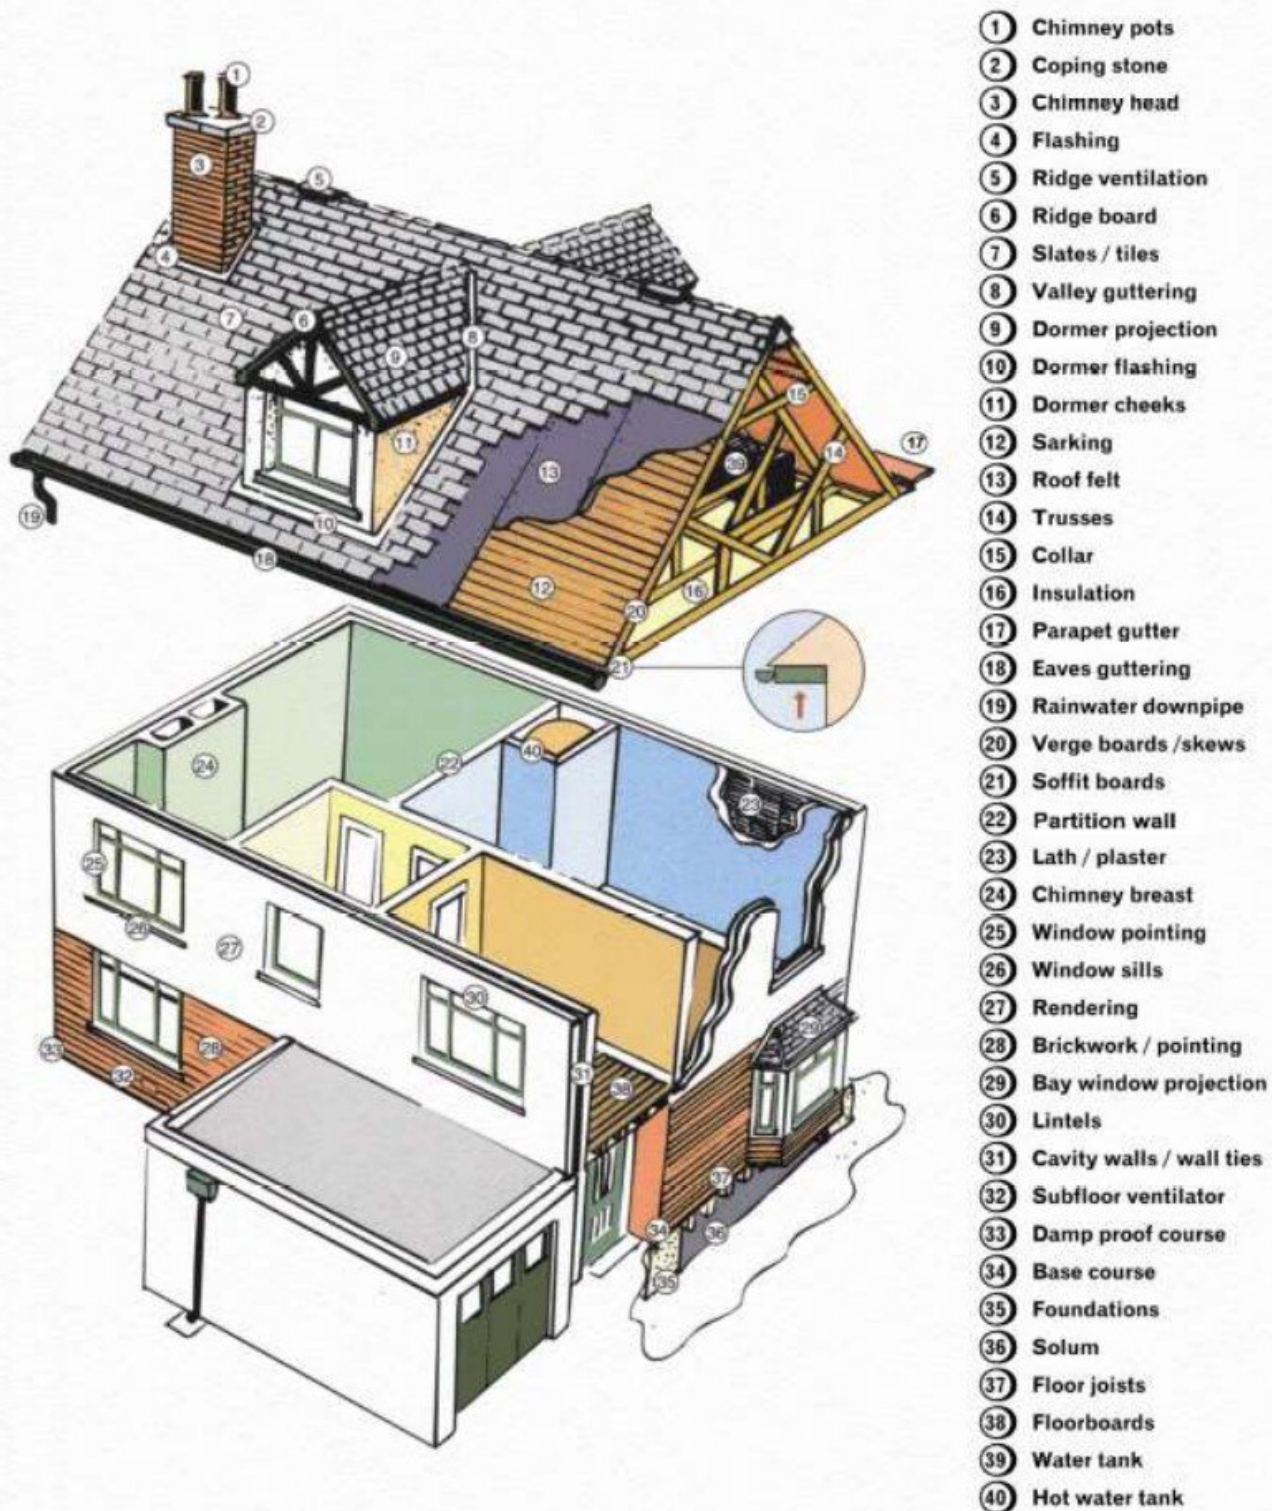
## Sectional Diagram showing elements of a typical house

Reference may be made in this report to some or all of the above component parts of the property. This diagram may assist you in locating and understanding these items.
