Home Report

Scottish Single Survey

Property address	110 Barrhill Road Cumnock KA18 1PU
-------------------------	--

Prepared by	Shepherd Chartered Surveyors
--------------------	------------------------------

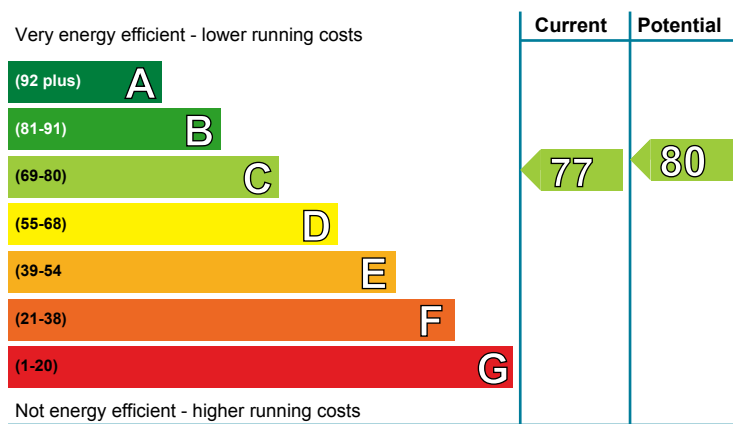
Energy Efficiency Rating

This graph shows the current efficiency of your home, taking into account both energy efficiency and fuel costs. The higher this rating, the lower your fuel bills are likely to be.

Your current rating is **band C (77)**. The average rating for EPCs in Scotland is **band D (61)**.

The potential rating shows the effect of undertaking all of the improvement measures listed within your recommendations report.

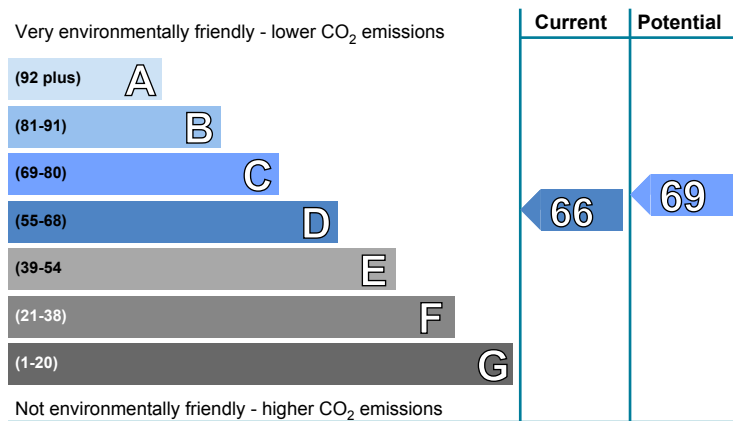
Environmental Impact (CO₂) Rating

This graph shows the effect of your home on the environment in terms of carbon dioxide (CO₂) emissions. The higher the rating, the less impact it has on the environment.
