YOUR ONESURVEY
HOME REPORT

131b Harbour Road
Gardenstown
Banff
AB45 3YS

SINGLE SURVEY

Single Survey

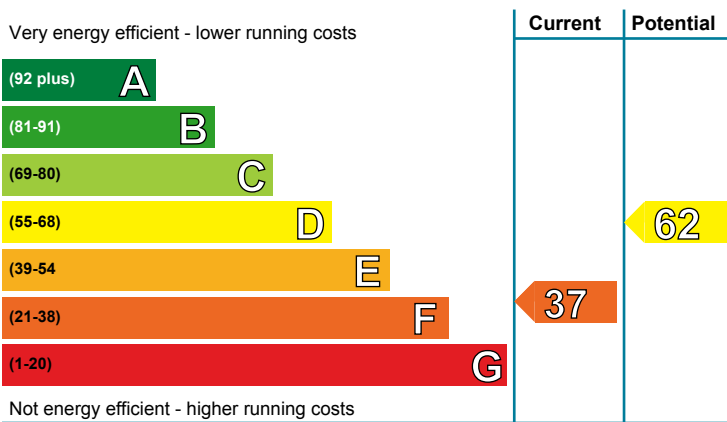
Energy Efficiency Rating

This graph shows the current efficiency of your home, taking into account both energy efficiency and fuel costs. The higher this rating, the lower your fuel bills are likely to be.

Your current rating is **band F (37)**. The average rating for EPCs in Scotland is **band D (61)**.

The potential rating shows the effect of undertaking all of the improvement measures listed within your recommendations report.

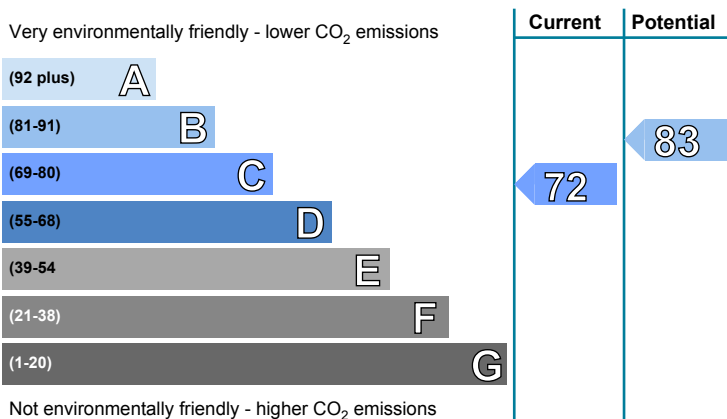
Environmental Impact (CO₂) Rating

This graph shows the effect of your home on the environment in terms of carbon dioxide (CO₂) emissions. The higher the rating, the less impact it has on the environment.
