Home Report

Single Survey

Property address	68 Manse View Motherwell ML1 5TB
Customer	Stephen Kelly
Customer address	68 Manse View Motherwell ML1 5TB
Prepared by	Shepherd Chartered Surveyors
Date of inspection	06/05/2026

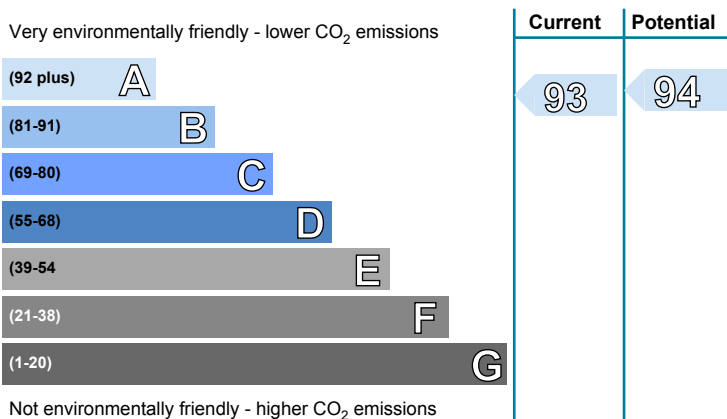
Environmental Impact (CO₂) Rating

This graph shows the effect of your home on the environment in terms of carbon dioxide (CO₂) emissions. The higher the rating, the less impact it has on the environment.
