HOME REPORT

149 SCOTT STREET
GALASHIELS
TD1 1DU

Energy Performance Certificate (EPC)

149 SCOTT STREET, GALASHIELS, TD1 1DU

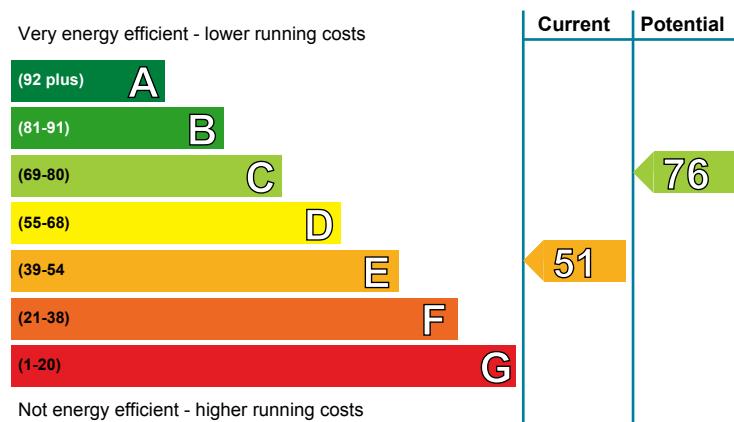
Energy Efficiency Rating

This graph shows the current efficiency of your home, taking into account both energy efficiency and fuel costs. The higher this rating, the lower your fuel bills are likely to be.

Your current rating is **band E (51)**. The average rating for EPCs in Scotland is **band D (61)**.

The potential rating shows the effect of undertaking all of the improvement measures listed within your recommendations report.

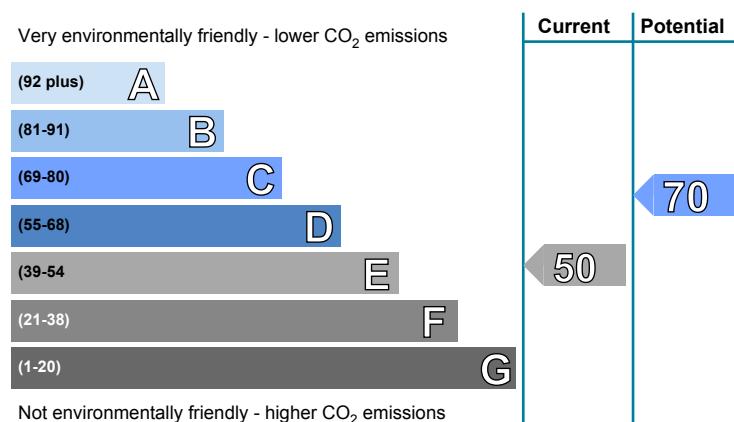
Environmental Impact (CO₂) Rating

This graph shows the effect of your home on the environment in terms of carbon dioxide (CO₂) emissions. The higher the rating, the less impact it has on the environment.

Your current rating is **band E (50)**

The potential rating shows the effect of undertaking all of the improvement measures listed within your recommendations report.

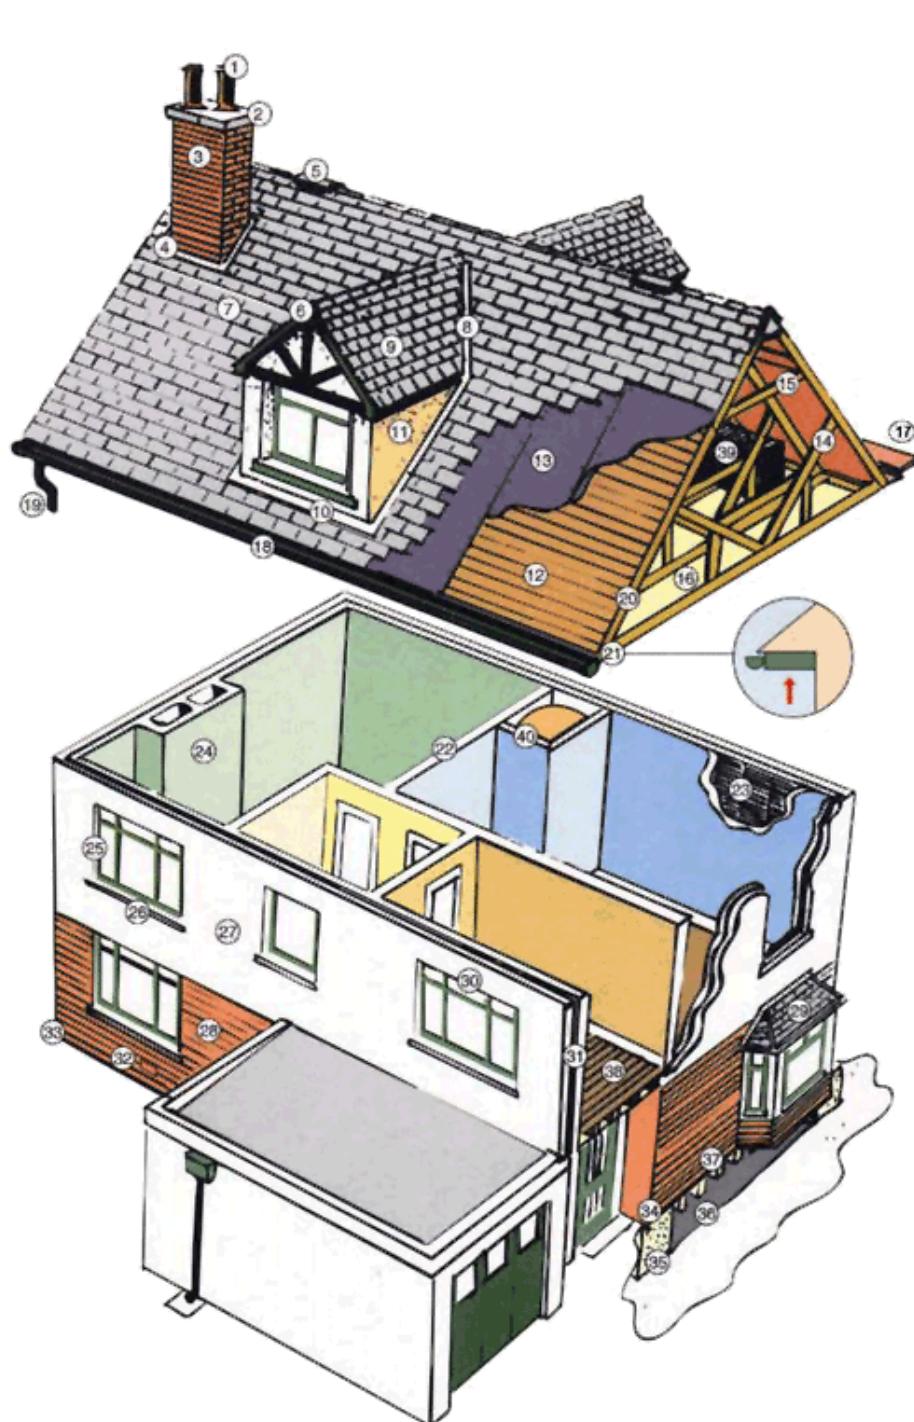
Sectional Diagram showing elements of a typical house

- 1 Chimney pots
- 2 Coping stone
- 3 Chimney head
- 4 Flashing
- 5 Ridge ventilation
- 6 Ridge board
- 7 Slates / tiles
- 8 Valley guttering
- 9 Dormer projection
- 10 Dormer flashing
- 11 Dormer cheeks
- 12 Sarking
- 13 Roof felt
- 14 Trusses
- 15 Collar
- 16 Insulation
- 17 Parapet gutter
- 18 Eaves guttering
- 19 Rainwater downpipe
- 20 Verge boards /skews
- 21 Soffit boards
- 22 Partition wall
- 23 Lath / plaster
- 24 Chimney breast
- 25 Window pointing
- 26 Window sills
- 27 Rendering
- 28 Brickwork / pointing
- 29 Bay window projection
- 30 Lintels
- 31 Cavity walls / wall ties
- 32 Subfloor ventilator
- 33 Damp proof course
- 34 Base course
- 35 Foundations
- 36 Solum
- 37 Floor joists
- 38 Floorboards
- 39 Water tank
- 40 Hot water tank

Reference may be made in this report to some or all of the above component parts of the property. This diagram may assist you in locating and understanding these items.
