Home Report

39 Church Street,
Newtyle,
PH12 8TZ

Single Survey

Survey Report on:

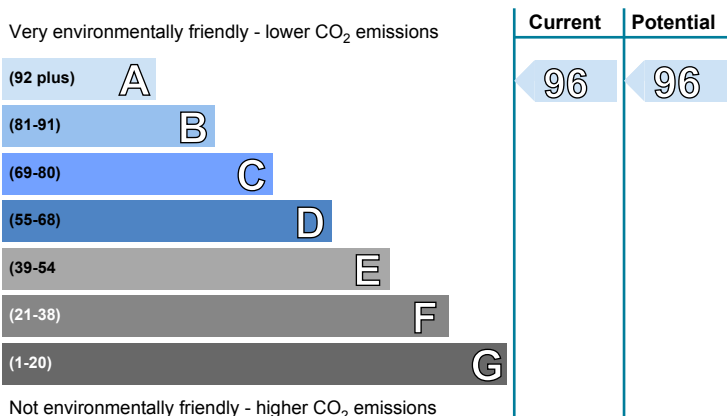
Environmental Impact (CO₂) Rating

This graph shows the effect of your home on the environment in terms of carbon dioxide (CO₂) emissions. The higher the rating, the less impact it has on the environment.
