YOUR ONESURVEY
HOME REPORT

6 McBain Place
Kinross
KY13 8QZ

SINGLE SURVEY

Single Survey

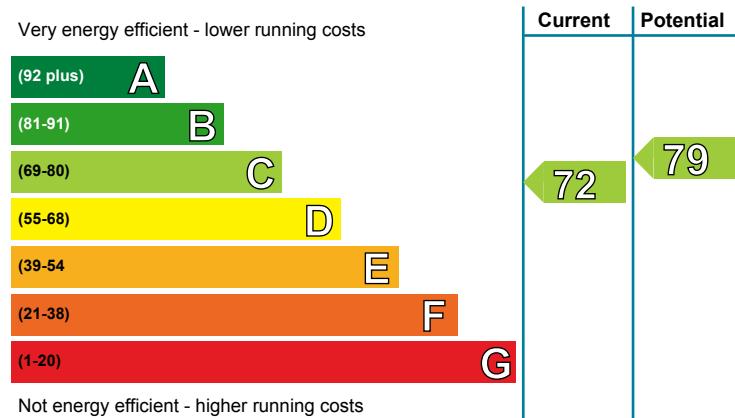
Energy Efficiency Rating

This graph shows the current efficiency of your home, taking into account both energy efficiency and fuel costs. The higher this rating, the lower your fuel bills are likely to be.

Your current rating is **band C (72)**. The average rating for EPCs in Scotland is **band D (61)**.

The potential rating shows the effect of undertaking all of the improvement measures listed within your recommendations report.

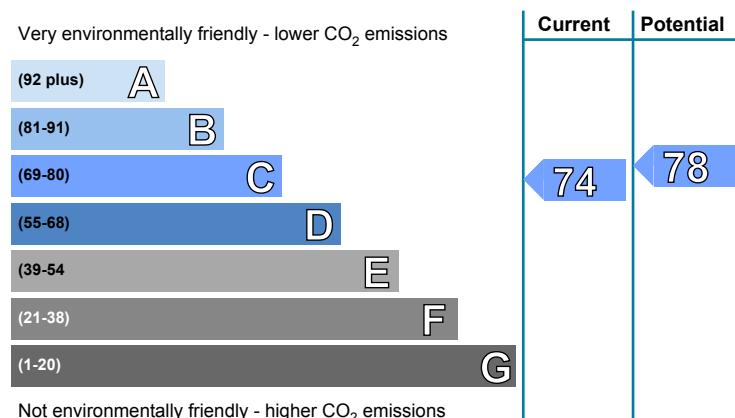
Environmental Impact (CO₂) Rating

This graph shows the effect of your home on the environment in terms of carbon dioxide (CO₂) emissions. The higher the rating, the less impact it has on the environment.
