# Home Report

# Single Survey

| Property address | 18 Broom Crescent<br>Ochiltree<br>Cumnock<br>KA18 2PS |
| Prepared by | Shepherd Chartered Surveyors |

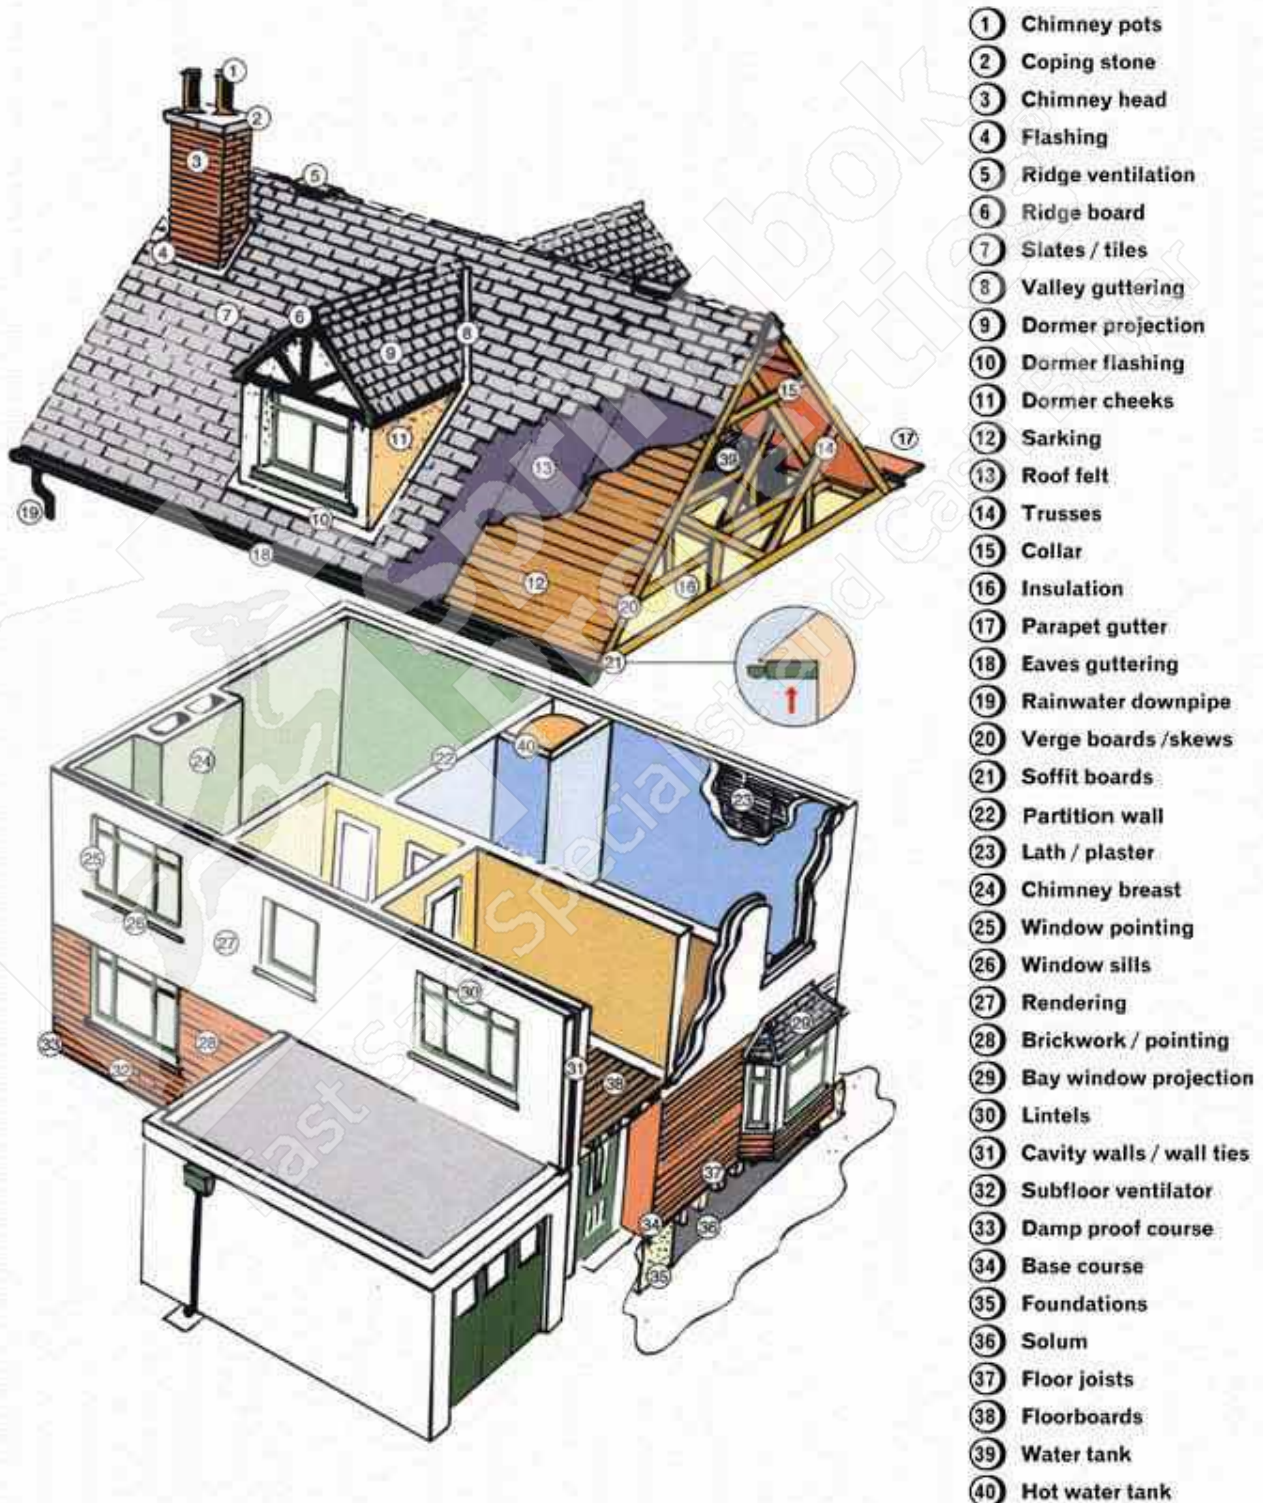
## Sectional Diagram showing elements of a typical house

Reference may be made in this report to some or all of the above component parts of the property. This diagram may assist you in locating and understanding these items.
