Home Report

19 Maryknowe
Gauldry Newport-On-Tay DD6 8SL

Single Survey

Property Address	19 Maryknowe Newport-On-Tay DD6 8SL
Customer	Karen Campbell
Prepared by	Graham + Sibbald Property Consultants Limited
Date of Inspection	15/01/2026

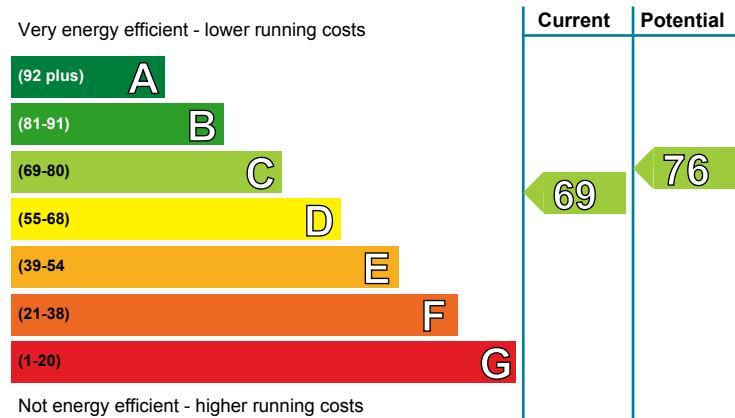
Energy Efficiency Rating

This graph shows the current efficiency of your home, taking into account both energy efficiency and fuel costs. The higher this rating, the lower your fuel bills are likely to be.

Your current rating is **band C (69)**. The average rating for EPCs in Scotland is **band D (61)**.

The potential rating shows the effect of undertaking all of the improvement measures listed within your recommendations report.

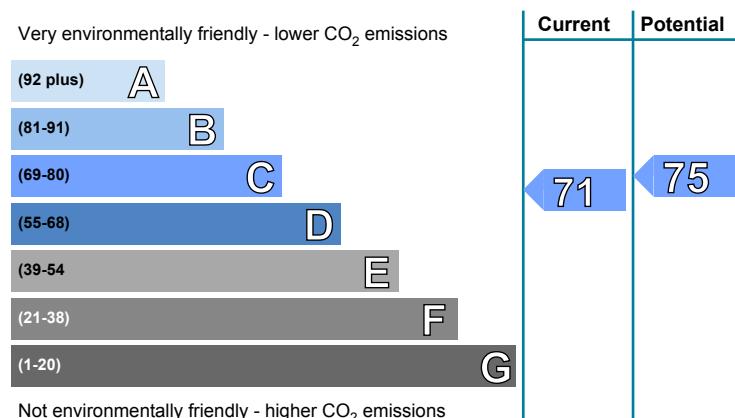
Environmental Impact (CO₂) Rating

This graph shows the effect of your home on the environment in terms of carbon dioxide (CO₂) emissions. The higher the rating, the less impact it has on the environment.
