4 Argyll Avenue,  
Falkirk,  
Stirlingshire,  
FK2 9EZ

# Home Report

# Single Survey

## Survey Report on:

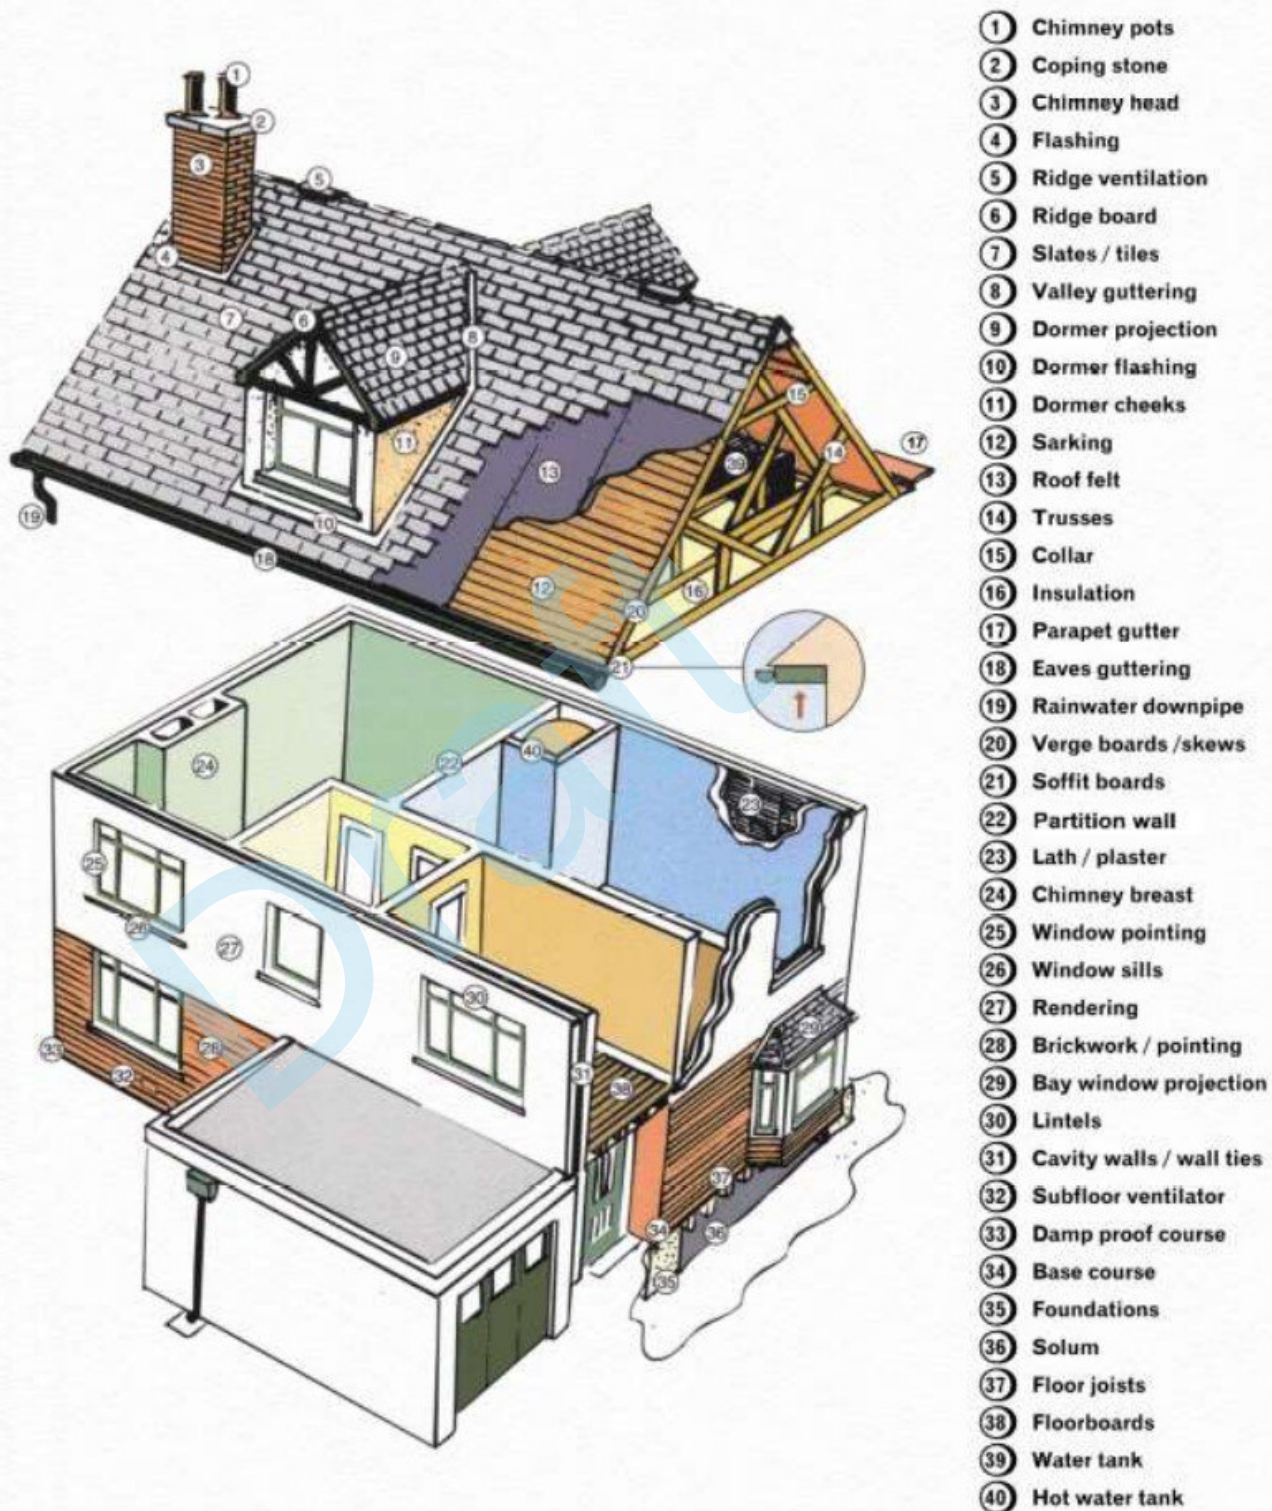
## Sectional Diagram showing elements of a typical house

Reference may be made in this report to some or all of the above component parts of the property. This diagram may assist you in locating and understanding these items.
