236 King Street,  
Broughty Ferry,  
Dundee,  
Angus,  
DD5 2AY

# Home Report

# Single Survey

<b>Property Address</b>	236 King Street, Broughty Ferry, Dundee, Angus, DD5 2AY
<b>Reference</b>	DD202511-45211
<b>Customer Name</b>	Jeff Stewart
<b>Date of Inspection</b>	13th February 2026
<b>Surveyor's name, qualifications and office</b>	Jack Chinery AssocRICS DM Hall LLP Chartered Surveyors Shed 26, Unit 34, City Quay Camperdown Street Dundee DD1 3JA  Tel: 01382 873100  email: <a href="mailto:dundeeresidential@dmhall.co.uk">dundeeresidential@dmhall.co.uk</a>
<b>Prepared By</b>	DM Hall LLP

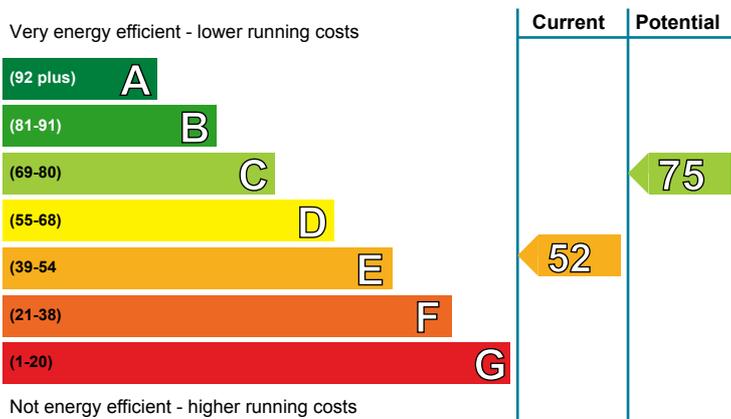
## Energy Efficiency Rating

This graph shows the current efficiency of your home, taking into account both energy efficiency and fuel costs. The higher this rating, the lower your fuel bills are likely to be.

Your current rating is **band E (52)**. The average rating for EPCs in Scotland is **band D (61)**.

The potential rating shows the effect of undertaking all of the improvement measures listed within your recommendations report.

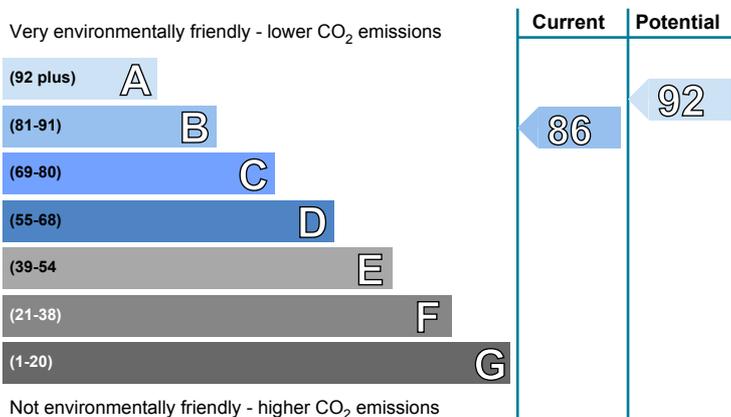
## Environmental Impact (CO<sub>2</sub>) Rating

This graph shows the effect of your home on the environment in terms of carbon dioxide (CO<sub>2</sub>) emissions. The higher the rating, the less impact it has on the environment.
