# Single Survey

| <b>Property Address</b> | 12 Coopers Brae Longside Peterhead AB42 4TN |
| <b>Prepared by</b> | Keith Alexander<br>Harvey Donaldson & Gibson Chartered Surveyors |

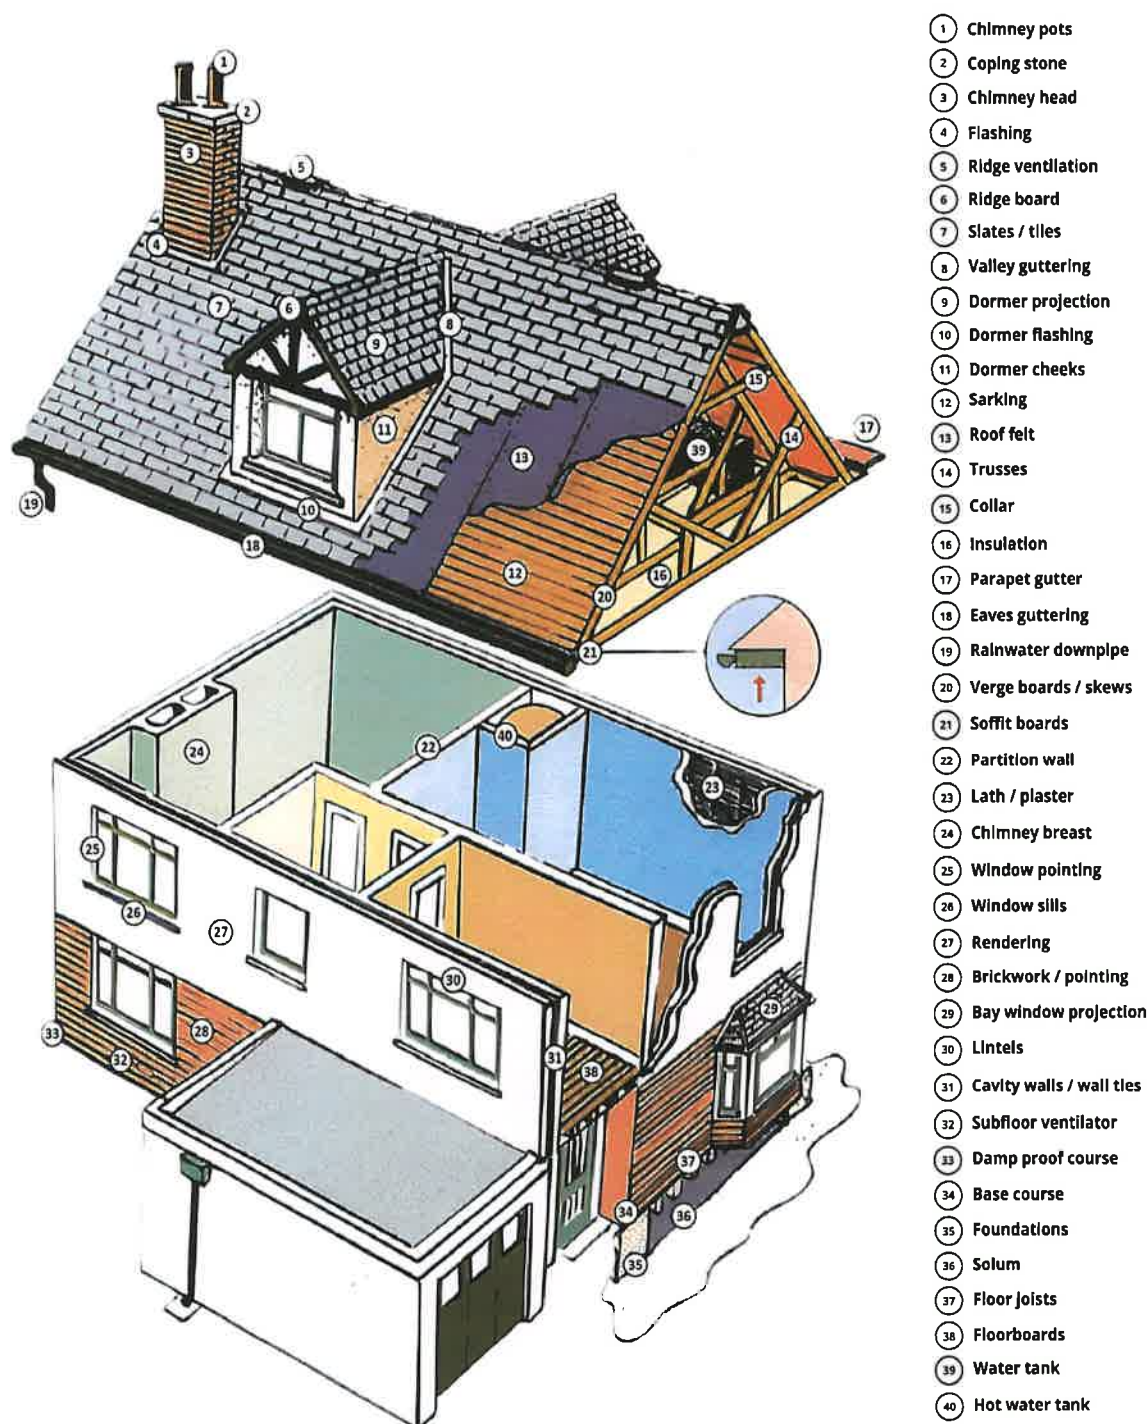
## Sectional Diagram showing elements of a typical house

Reference may be made in this report to some or all of the above component parts of the property. This diagram may assist you in locating and understanding these items.
