# Home Report

# Scottish Single Survey

# Single Survey

| Property address | 99 Valley Gardens South<br>Kirkcaldy<br>KY2 6AX |

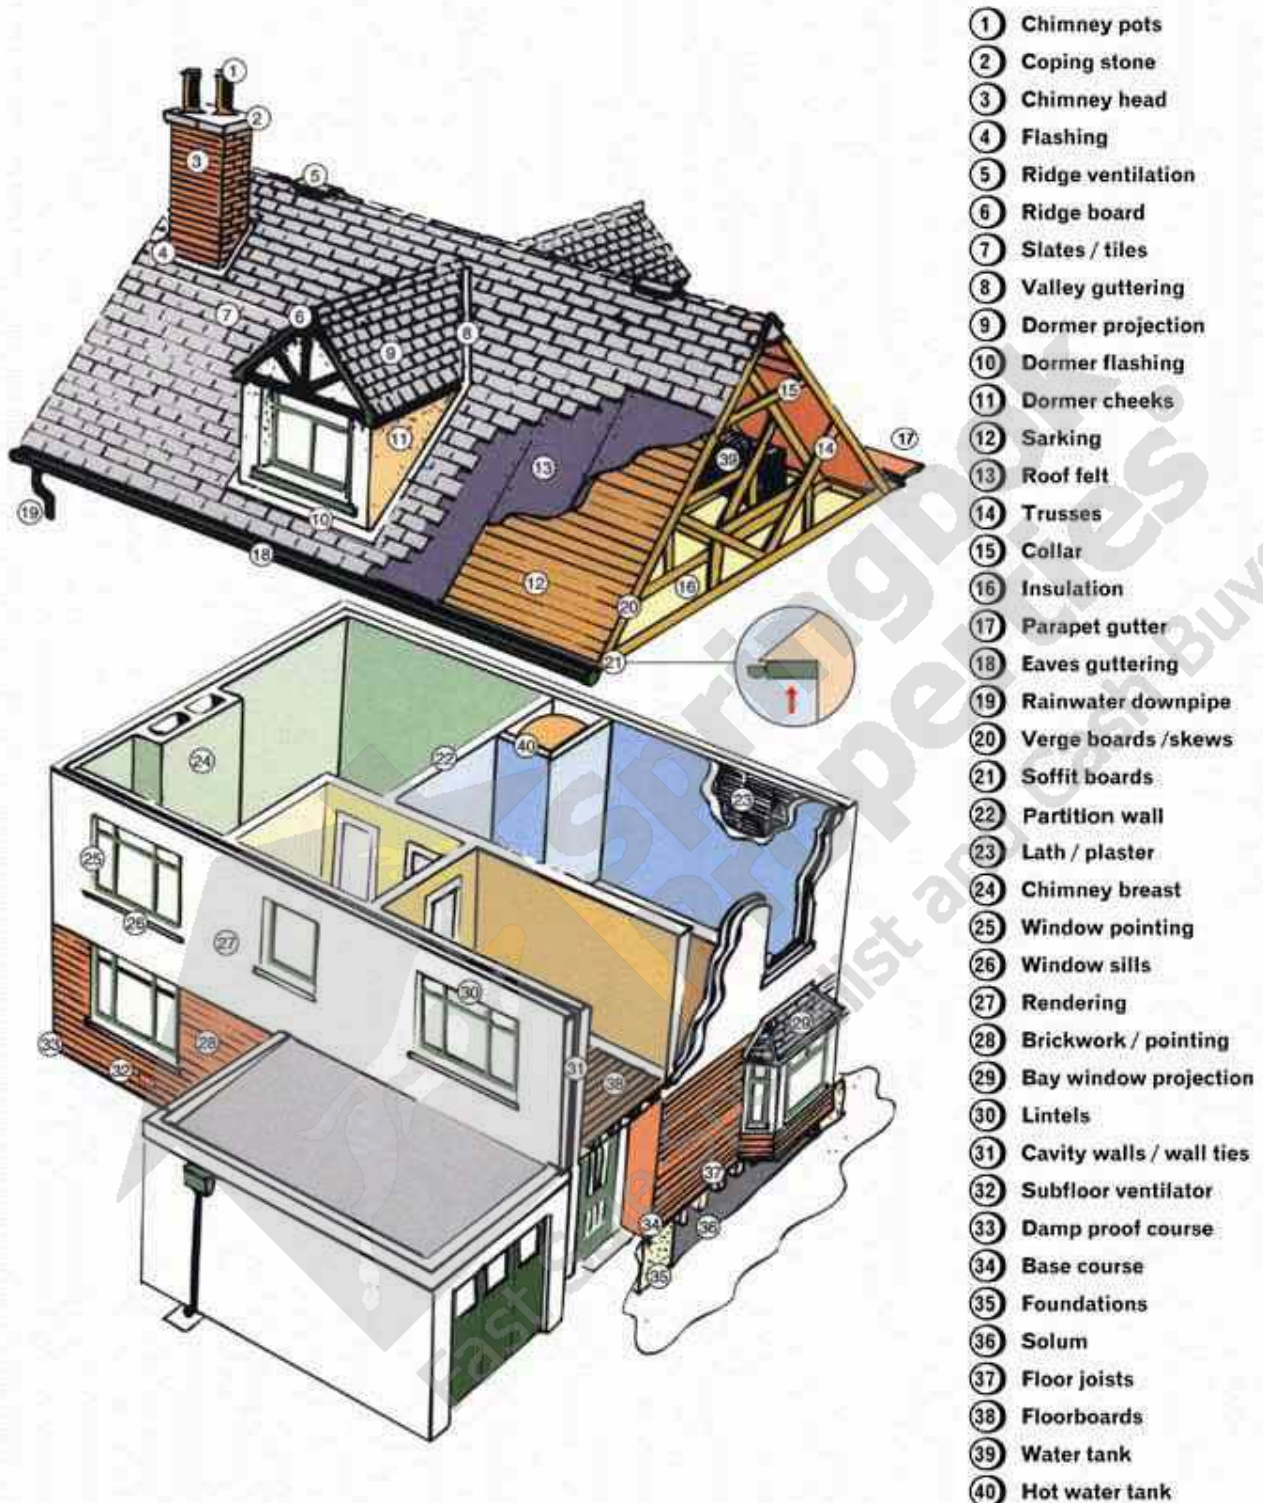
## Sectional Diagram showing elements of a typical house

Reference may be made in this report to some or all of the above component parts of the property. This diagram may assist you in locating and understanding these items.
