# Home Report

# Scottish Single Survey

survey report on:

| Property address | Meikledalehaugh<br>Langholm<br>DG13 0HW |

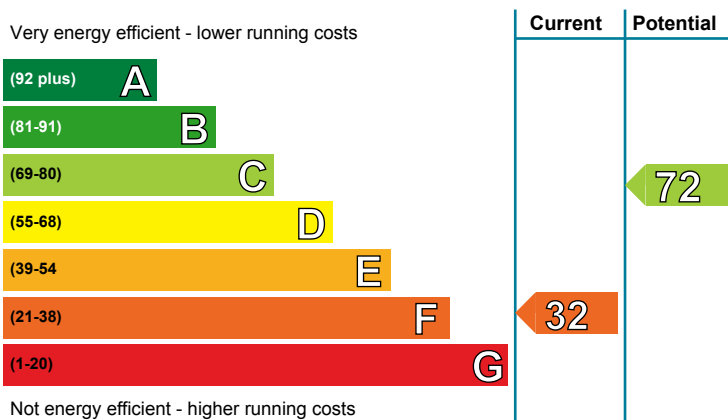
## Energy Efficiency Rating

This graph shows the current efficiency of your home, taking into account both energy efficiency and fuel costs. The higher this rating, the lower your fuel bills are likely to be.

Your current rating is **band F (32)**. The average rating for EPCs in Scotland is **band D (61)**.

The potential rating shows the effect of undertaking all of the improvement measures listed within your recommendations report.
