YOUR ONESURVEY
HOME REPORT

Flat 4
57 Partick Bridge Street
Glasgow
G11 6PQ

SINGLE SURVEY

Single Survey

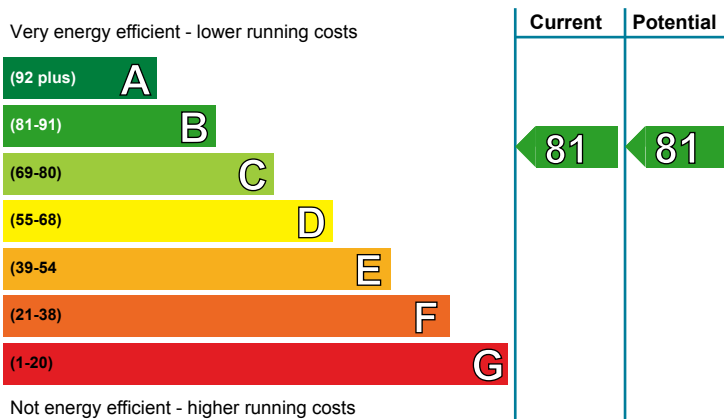
Energy Efficiency Rating

This graph shows the current efficiency of your home, taking into account both energy efficiency and fuel costs. The higher this rating, the lower your fuel bills are likely to be.

Your current rating is **band B (81)**. The average rating for EPCs in Scotland is **band D (61)**.

The potential rating shows the effect of undertaking all of the improvement measures listed within your recommendations report.

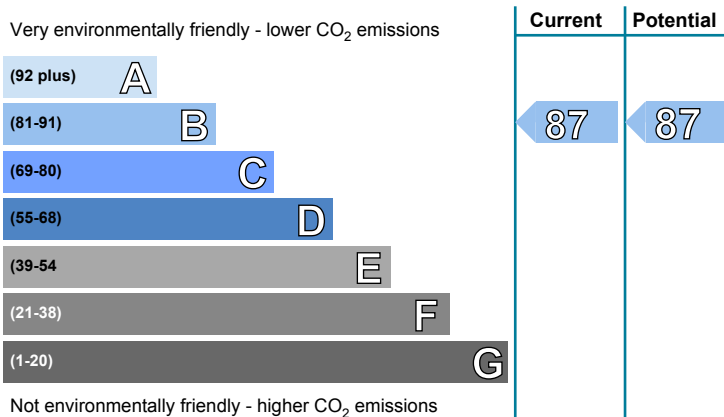
Environmental Impact (CO₂) Rating

This graph shows the effect of your home on the environment in terms of carbon dioxide (CO₂) emissions. The higher the rating, the less impact it has on the environment.
