# Home Report

# Single Survey

## Survey Report on:

<b>Property Address</b>	Flat 1, 24, Donaldson Street, Kirkintilloch, GLASGOW, G66 1XB
<b>Reference</b>	1463238
<b>Customer Name</b>	Carole McDougall
<b>Date of Inspection</b>	2nd March 2026
<b>Surveyor's name, qualifications and office</b>	Derek Anderson MRICS DM Hall LLP Chartered Surveyors Suite 2C 1 Pitt Terrace Stirling FK8 2EZ  Tel: 01786 475785  email: <a href="mailto:stirlingresidential@dmhall.co.uk">stirlingresidential@dmhall.co.uk</a>
<b>Prepared By</b>	DM Hall LLP

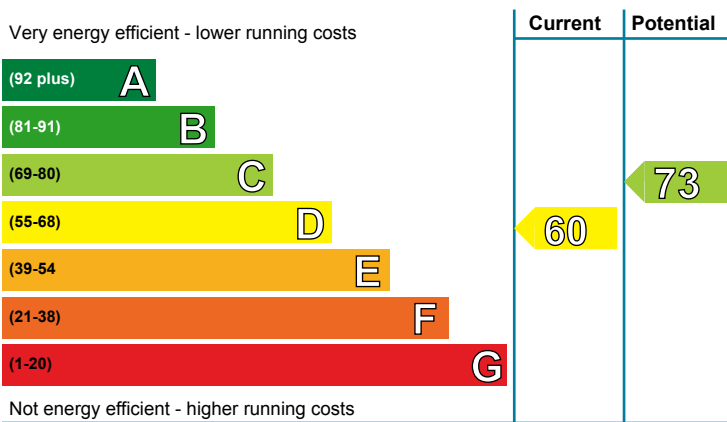
## Energy Efficiency Rating

This graph shows the current efficiency of your home, taking into account both energy efficiency and fuel costs. The higher this rating, the lower your fuel bills are likely to be.

Your current rating is **band D (60)**. The average rating for EPCs in Scotland is **band D (61)**.

The potential rating shows the effect of undertaking all of the improvement measures listed within your recommendations report.

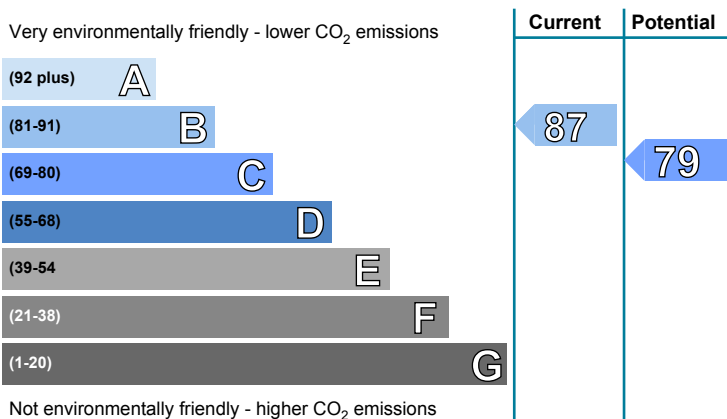
## Environmental Impact (CO<sub>2</sub>) Rating

This graph shows the effect of your home on the environment in terms of carbon dioxide (CO<sub>2</sub>) emissions. The higher the rating, the less impact it has on the environment.
