# SINGLE SURVEY

A report on the condition of the property, with categories  
being rated from 1 to 3.

| <b>Selling address</b> | 79e Shawhill Road<br>Glasgow<br>G41 3RW |
| <b>Prepared by</b> | Gary Firth, MRICS<br>Glasgow South - Allied Surveyors Scotland Ltd |

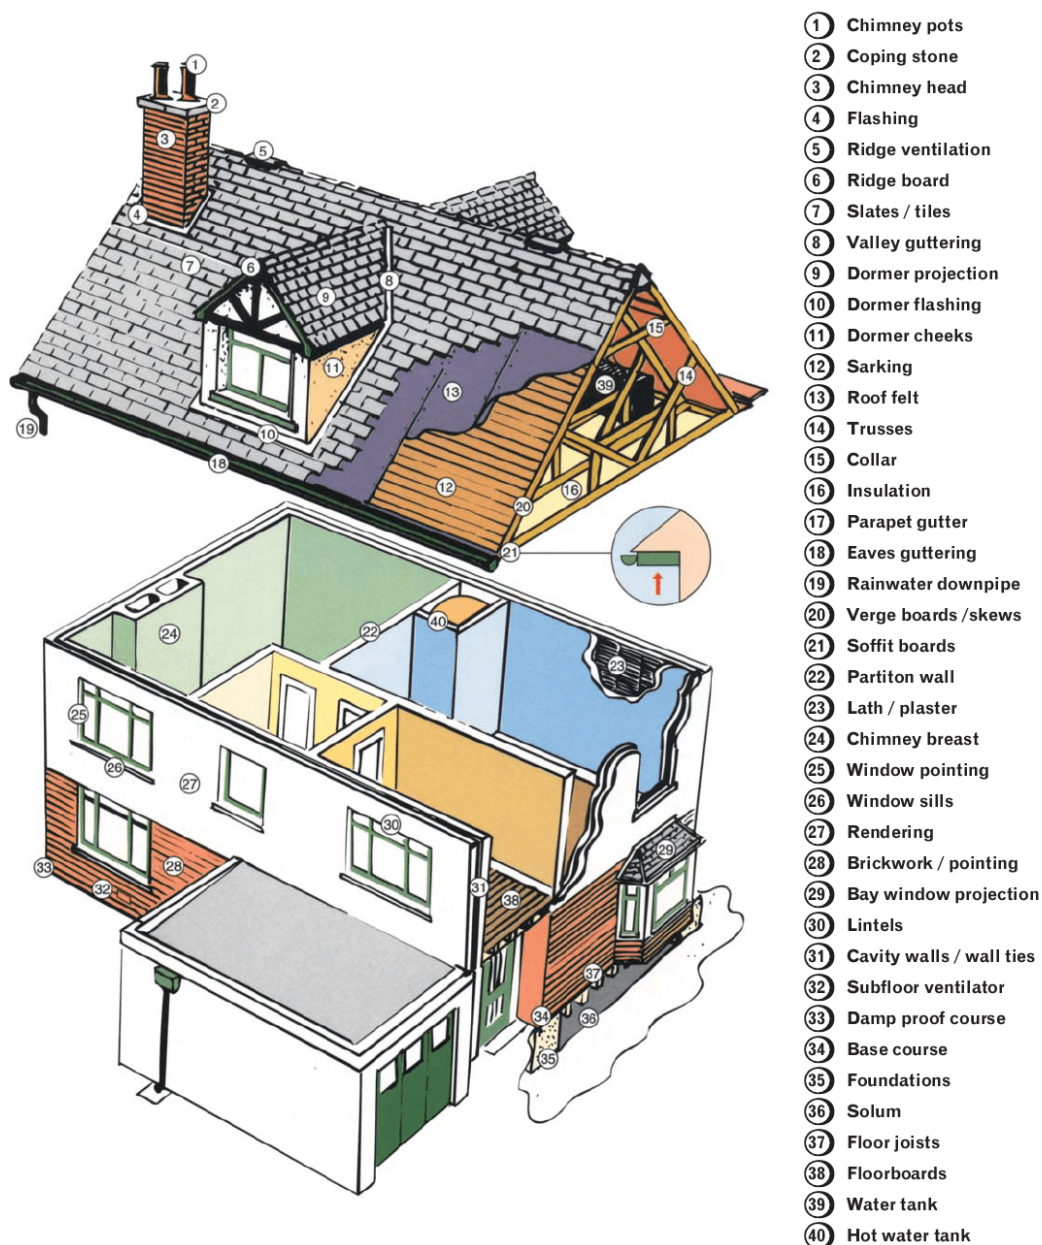
## Sectional Diagram showing elements of a typical house

Reference may be made in this report to some or all of the above component parts of the property. This diagram may assist you in locating and understanding these items.
