Home Report

Single Survey

Property address	15 Loch Striven East Kilbride Glasgow G74 2EQ
Customer	Joe McDonald
Customer address	15 Loch Striven East Kilbride Glasgow G74 2EQ
Prepared by	Shepherd Chartered Surveyors
Date of inspection	22/01/2026

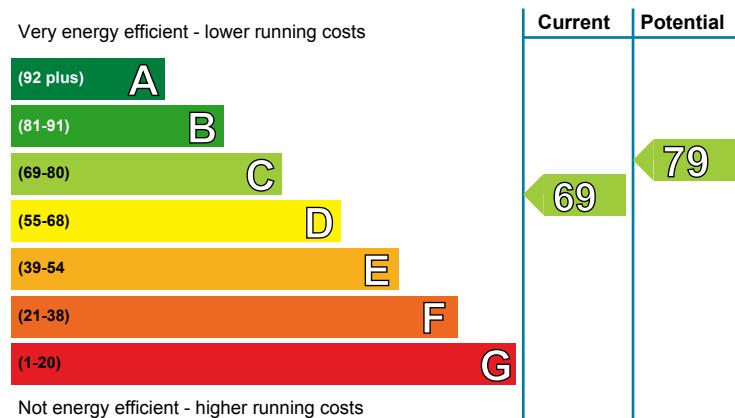
Energy Efficiency Rating

This graph shows the current efficiency of your home, taking into account both energy efficiency and fuel costs. The higher this rating, the lower your fuel bills are likely to be.

Your current rating is **band C (69)**. The average rating for EPCs in Scotland is **band D (61)**.

The potential rating shows the effect of undertaking all of the improvement measures listed within your recommendations report.

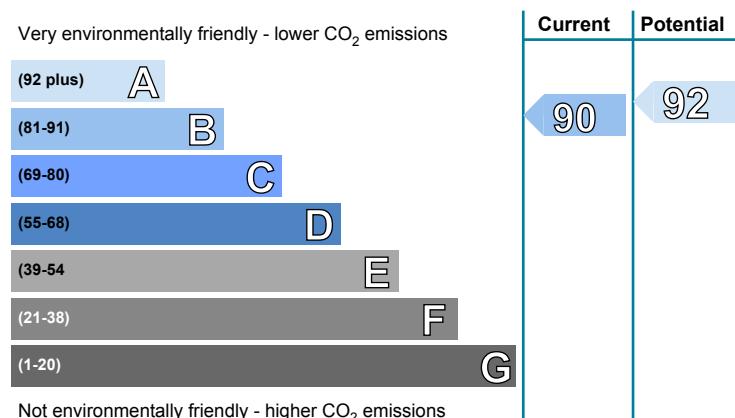
Environmental Impact (CO₂) Rating

This graph shows the effect of your home on the environment in terms of carbon dioxide (CO₂) emissions. The higher the rating, the less impact it has on the environment.
