YOUR ONESURVEY
HOME REPORT

178a Victoria Road
Aberdeen
AB11 9NN

Single Survey

Prepared by	Steven Wilson, MRICS BSc Hons J & E Shepherd - Aberdeen
--------------------	--

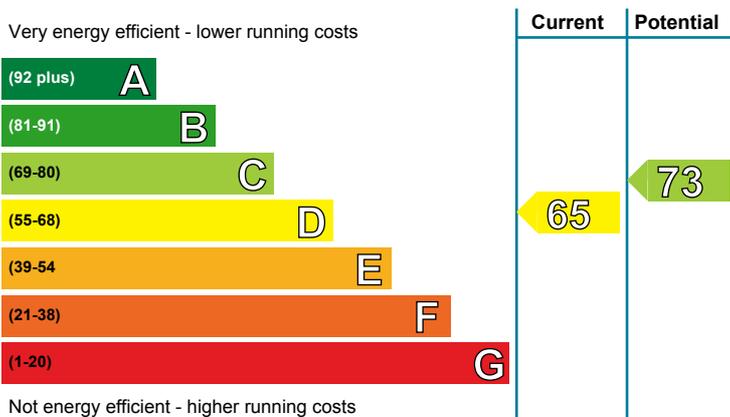
Energy Efficiency Rating

This graph shows the current efficiency of your home, taking into account both energy efficiency and fuel costs. The higher this rating, the lower your fuel bills are likely to be.

Your current rating is **band D (65)**. The average rating for EPCs in Scotland is **band D (61)**.

The potential rating shows the effect of undertaking all of the improvement measures listed within your recommendations report.

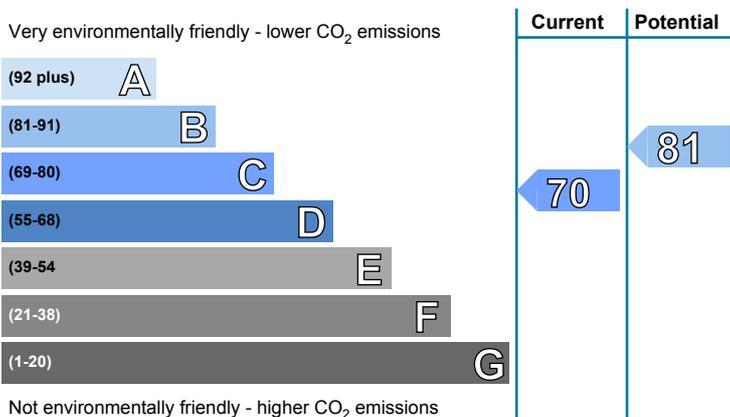
Environmental Impact (CO₂) Rating

This graph shows the effect of your home on the environment in terms of carbon dioxide (CO₂) emissions. The higher the rating, the less impact it has on the environment.
