66 Harestane Road,
Dundee,
DD3 0LH

Home Report

Survey Report on:

Property Address	66 Harestane Road, Dundee, DD3 0LH
Reference	DD202605-60014
Customer Name	Duncan MacLean
Date of Inspection	18th May 2026
Surveyor's name, qualifications and office	Jack Chinery AssocRICS DM Hall LLP Chartered Surveyors Shed 26, Unit 34, City Quay Camperdown Street Dundee DD1 3JA Tel: 01382 873100 email: dundeeresidential@dmhall.co.uk
Prepared By	DM Hall LLP

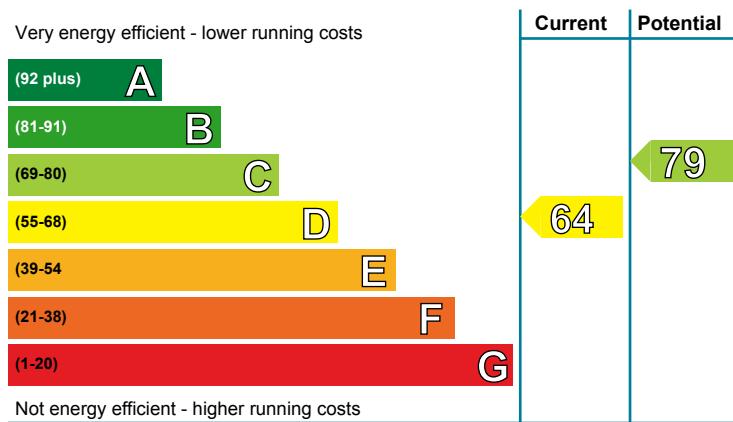
Energy Efficiency Rating

This graph shows the current efficiency of your home, taking into account both energy efficiency and fuel costs. The higher this rating, the lower your fuel bills are likely to be.

Your current rating is **band D (64)**. The average rating for EPCs in Scotland is **band D (61)**.

The potential rating shows the effect of undertaking all of the improvement measures listed within your recommendations report.

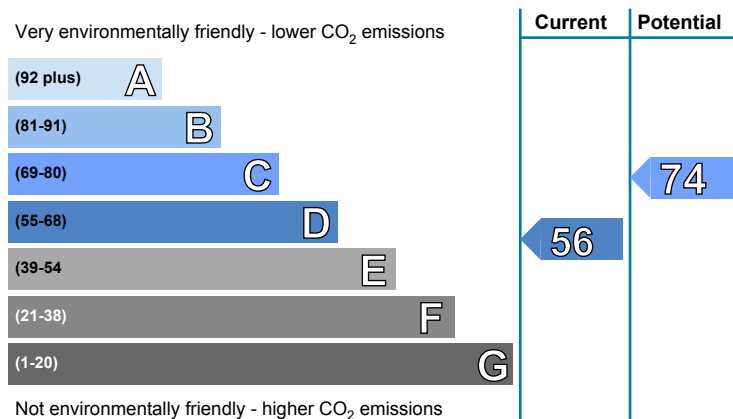
Environmental Impact (CO₂) Rating

This graph shows the effect of your home on the environment in terms of carbon dioxide (CO₂) emissions. The higher the rating, the less impact it has on the environment.
