# Home Report

# Single Survey

## Survey Report on:

Kinnell House,  
Midton Road,  
Howwood,  
Johnstone,  
PA9 1AG

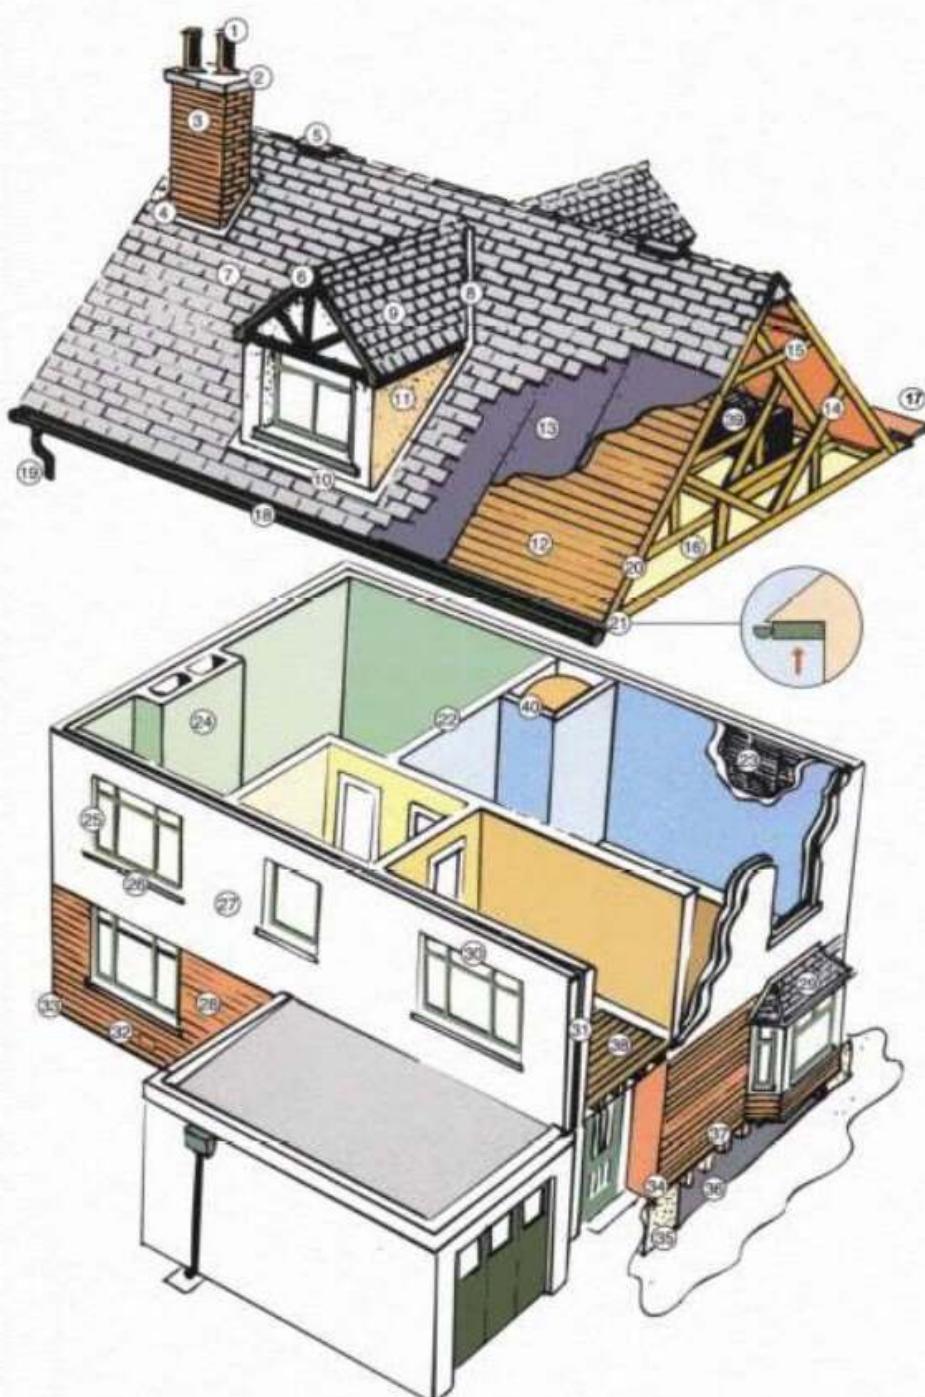
## Sectional Diagram showing elements of a typical house

- 1 Chimney pots
- 2 Coping stone
- 3 Chimney head
- 4 Flashing
- 5 Ridge ventilation
- 6 Ridge board
- 7 Slates / tiles
- 8 Valley guttering
- 9 Dormer projection
- 10 Dormer flashing
- 11 Dormer cheeks
- 12 Sarking
- 13 Roof felt
- 14 Trusses
- 15 Collar
- 16 Insulation
- 17 Parapet gutter
- 18 Eaves guttering
- 19 Rainwater downpipe
- 20 Verge boards / skewers
- 21 Soffit boards
- 22 Partition wall
- 23 Lath / plaster
- 24 Chimney breast
- 25 Window pointing
- 26 Window sills
- 27 Rendering
- 28 Brickwork / pointing
- 29 Bay window projection
- 30 Lintels
- 31 Cavity walls / wall ties
- 32 Subfloor ventilator
- 33 Damp proof course
- 34 Base course
- 35 Foundations
- 36 Solum
- 37 Floor joists
- 38 Floorboards
- 39 Water tank
- 40 Hot water tank

Reference may be made in this report to some or all of the above component parts of the property. This diagram may assist you in locating and understanding these items.

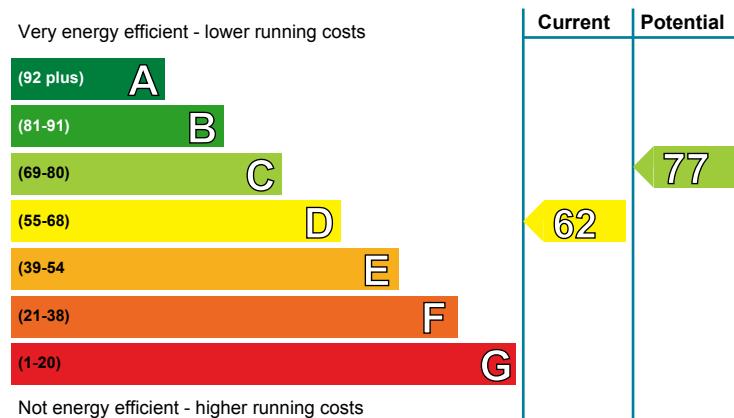
## Energy Efficiency Rating

This graph shows the current efficiency of your home, taking into account both energy efficiency and fuel costs. The higher this rating, the lower your fuel bills are likely to be.

Your current rating is **band D (62)**. The average rating for EPCs in Scotland is **band D (61)**.

The potential rating shows the effect of undertaking all of the improvement measures listed within your recommendations report.

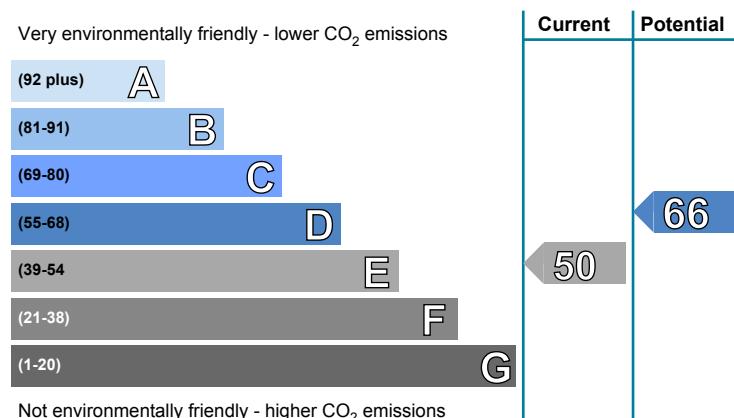
## Environmental Impact (CO<sub>2</sub>) Rating

This graph shows the effect of your home on the environment in terms of carbon dioxide (CO<sub>2</sub>) emissions. The higher the rating, the less impact it has on the environment.
