# Single Survey

<b>Property address</b>	112 MAIN STREET, AYR, KA8 8EF
-------------------------	-------------------------------------

<b>Prepared by</b>	DM Hall LLP
--------------------	-------------

<b>Date of inspection</b>	14th July 2025
---------------------------	----------------

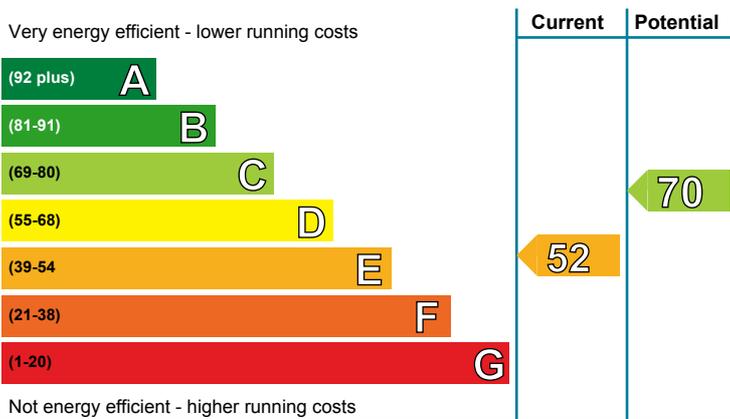
## Energy Efficiency Rating

This graph shows the current efficiency of your home, taking into account both energy efficiency and fuel costs. The higher this rating, the lower your fuel bills are likely to be.

Your current rating is **band E (52)**. The average rating for EPCs in Scotland is **band D (61)**.

The potential rating shows the effect of undertaking all of the improvement measures listed within your recommendations report.

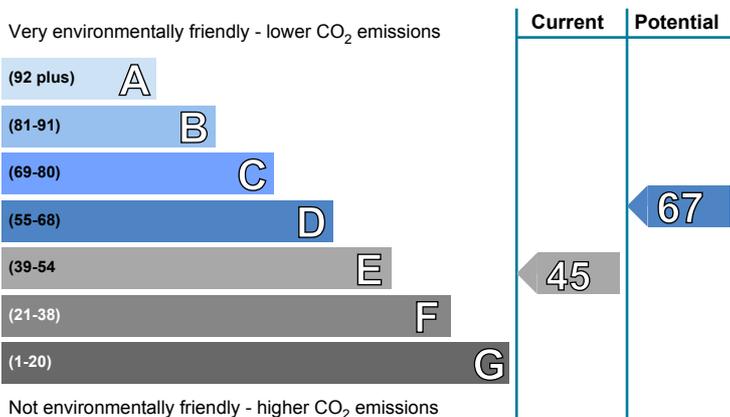
## Environmental Impact (CO<sub>2</sub>) Rating

This graph shows the effect of your home on the environment in terms of carbon dioxide (CO<sub>2</sub>) emissions. The higher the rating, the less impact it has on the environment.
