Home Report

Scottish Single Survey

| Property address | 6 Willie McKelvey Brae Kilmarnock KA1 3AD |
| Date of inspection | 21/01/2026 |

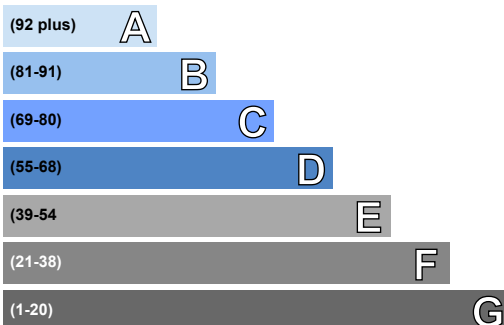
Very environmentally friendly - lower CO₂ emissions

Not environmentally friendly - higher CO₂ emissions
