YOUR ONESURVEY  
**HOME REPORT**

296 Kirk Road  
Wishaw  
ML2 7BZ

# SINGLE SURVEY

A report on the condition of the property, with categories being rated from 1 to 3.

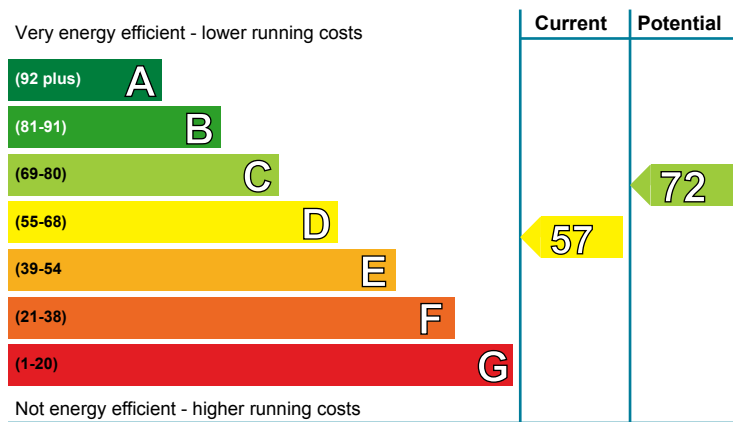
## Energy Efficiency Rating

This graph shows the current efficiency of your home, taking into account both energy efficiency and fuel costs. The higher this rating, the lower your fuel bills are likely to be.

Your current rating is **band D (57)**. The average rating for EPCs in Scotland is **band D (61)**.

The potential rating shows the effect of undertaking all of the improvement measures listed within your recommendations report.

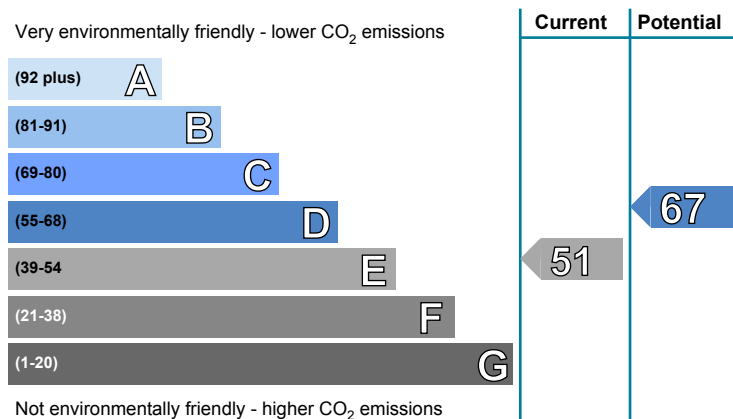
## Environmental Impact (CO<sub>2</sub>) Rating

This graph shows the effect of your home on the environment in terms of carbon dioxide (CO<sub>2</sub>) emissions. The higher the rating, the less impact it has on the environment.
