# YOUR ONESURVEY HOME REPORT

Flat 5  
Old Moffat Academy  
Academy Road  
Moffat, DG10 9FA

# SINGLE SURVEY

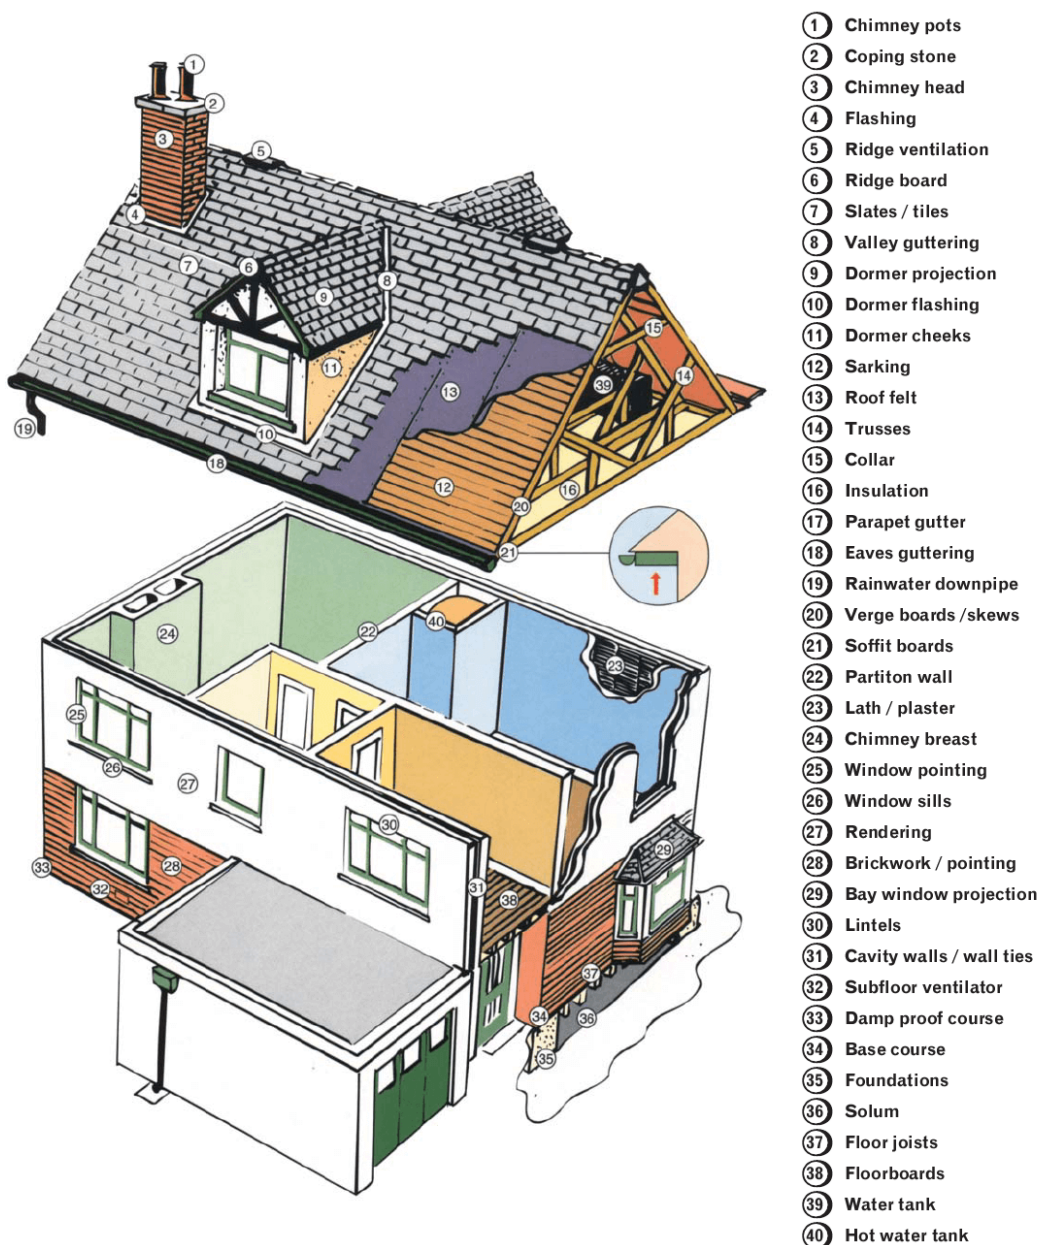
## Sectional Diagram showing elements of a typical house

Reference may be made in this report to some or all of the above component parts of the property. This diagram may assist you in locating and understanding these items.

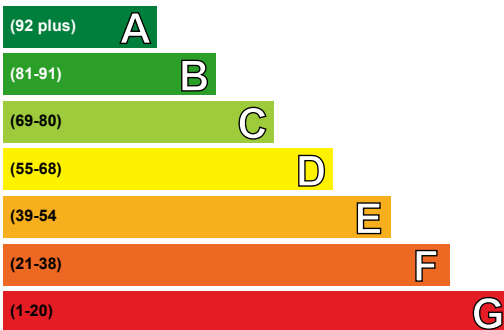
Very energy efficient - lower running costs

Not energy efficient - higher running costs

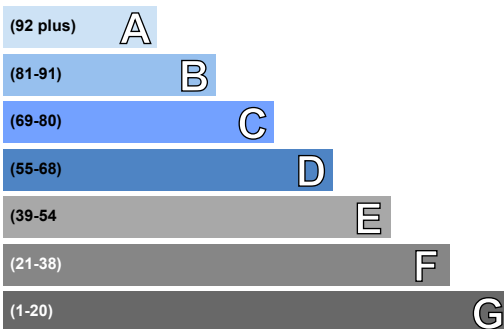
Very environmentally friendly - lower CO<sub>2</sub> emissions

Not environmentally friendly - higher CO<sub>2</sub> emissions
