# Home Report

# Single Survey

<b>Property address</b>	28 Stewart Crescent Lochgelly KY5 9PG
<b>Customer</b>	[REDACTED]
<b>Customer address</b>	28 Stewart Crescent Lochgelly KY5 9PG
<b>Prepared by</b>	Shepherd Chartered Surveyors
<b>Date of inspection</b>	06/05/2026

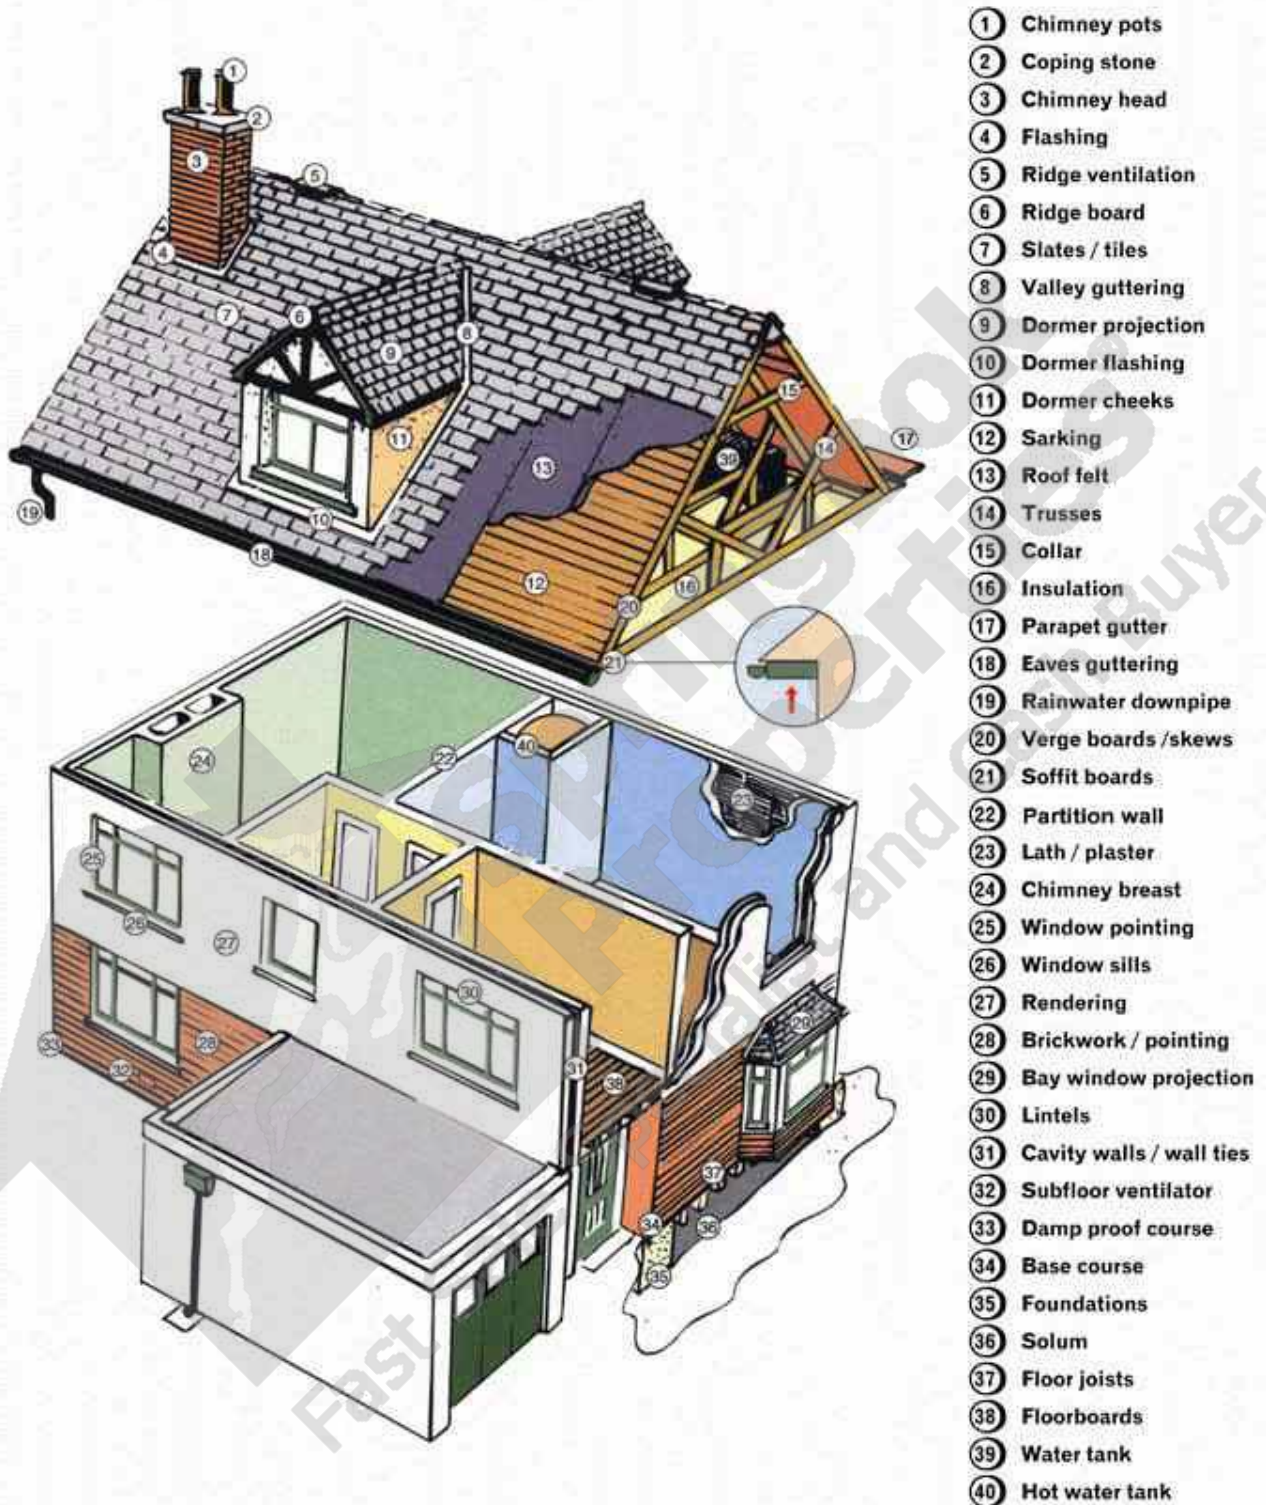
## Sectional Diagram showing elements of a typical house

Reference may be made in this report to some or all of the above component parts of the property. This diagram may assist you in locating and understanding these items.
