15 Thornly Park Avenue,
PAISLEY,
PA2 7SD

Home Report

Single Survey

Property Address	15 Thornly Park Avenue, PAISLEY, PA2 7SD
Reference	1581683
Customer Name	Crawford Copstick
Date of Inspection	13th May 2026
Surveyor's name, qualifications and office	David Cree BSc, MRICS DM Hall LLP Chartered Surveyors 3 Centura Court, Hillington Park Glasgow G52 4PR Tel: 0141 636 4141 email: glasgowresidential@dmhall.co.uk
Prepared By	DM Hall LLP

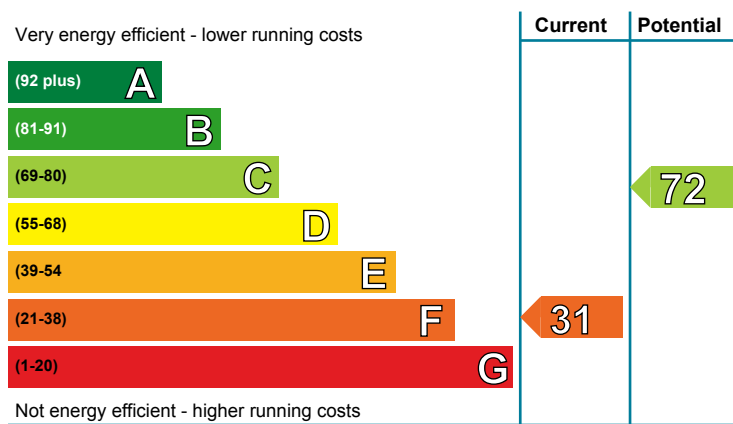
Energy Efficiency Rating

This graph shows the current efficiency of your home, taking into account both energy efficiency and fuel costs. The higher this rating, the lower your fuel bills are likely to be.

Your current rating is **band F (31)**. The average rating for EPCs in Scotland is **band D (61)**.

The potential rating shows the effect of undertaking all of the improvement measures listed within your recommendations report.

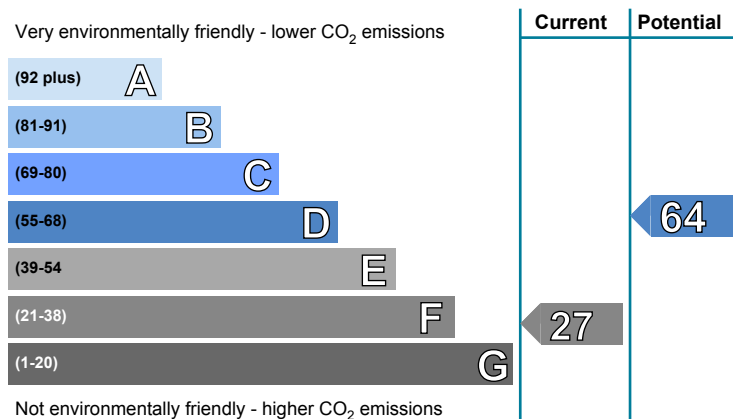
Environmental Impact (CO₂) Rating

This graph shows the effect of your home on the environment in terms of carbon dioxide (CO₂) emissions. The higher the rating, the less impact it has on the environment.
