3 Traill Street,
Broughty Ferry,
Dundee,
DD5 3AX

Home Report

Single Survey

Property Address	3 Traill Street, Broughty Ferry, Dundee, DD5 3AX
Reference	DD202606-63715
Customer Name	Audrey and Steve Clenaghan
Date of Inspection	26th June 2026
Surveyor's name, qualifications and office	Mark Smith BSc MRICS DM Hall LLP Chartered Surveyors Shed 26, Unit 34, City Quay Camperdown Street Dundee DD1 3JA Tel: 01382 873100 email: dundeeresidential@dmhall.co.uk
Prepared By	DM Hall LLP

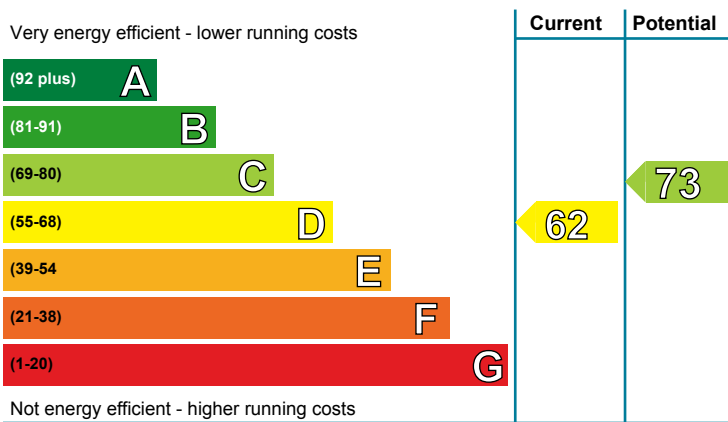
Energy Efficiency Rating

This graph shows the current efficiency of your home, taking into account both energy efficiency and fuel costs. The higher this rating, the lower your fuel bills are likely to be.

Your current rating is **band D (62)**. The average rating for EPCs in Scotland is **band D (61)**.

The potential rating shows the effect of undertaking all of the improvement measures listed within your recommendations report.

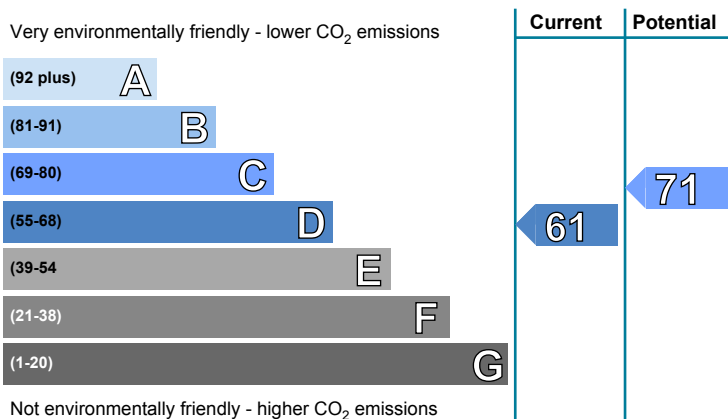
Environmental Impact (CO₂) Rating

This graph shows the effect of your home on the environment in terms of carbon dioxide (CO₂) emissions. The higher the rating, the less impact it has on the environment.
