YOUR ONESURVEY
HOME REPORT

Netherby House
Eaglesfield
Lockerbie
DG11 3PD

SINGLE SURVEY

Single Survey

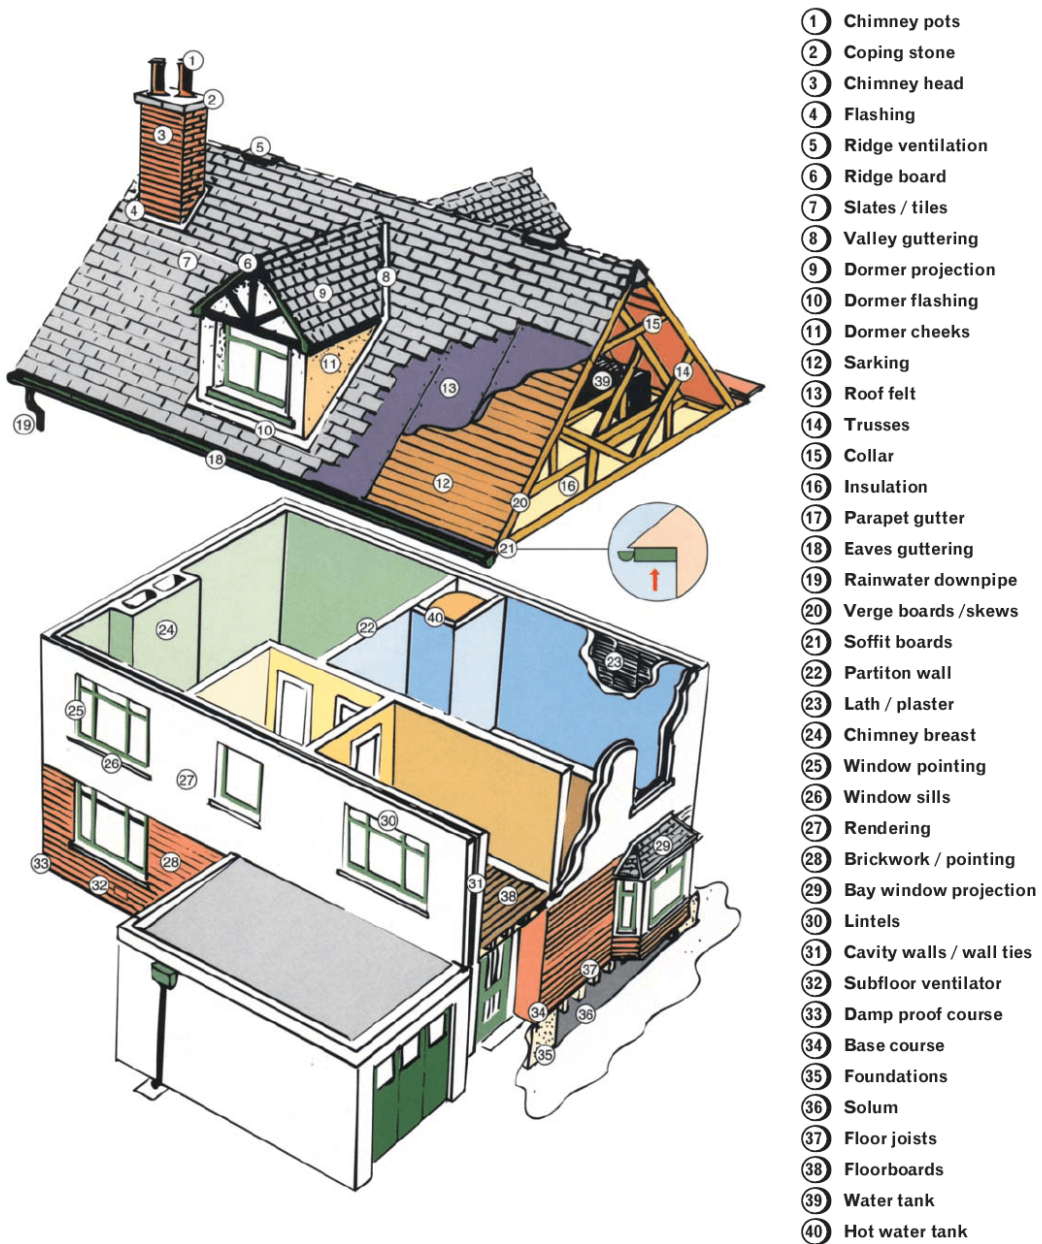
Sectional Diagram showing elements of a typical house

Reference may be made in this report to some or all of the above component parts of the property. This diagram may assist you in locating and understanding these items.

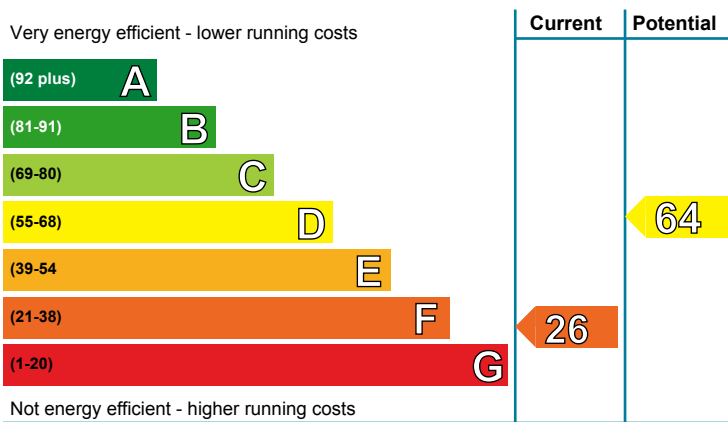
Energy Efficiency Rating

This graph shows the current efficiency of your home, taking into account both energy efficiency and fuel costs. The higher this rating, the lower your fuel bills are likely to be.

Your current rating is **band F (26)**. The average rating for EPCs in Scotland is **band D (61)**.

The potential rating shows the effect of undertaking all of the improvement measures listed within your recommendations report.

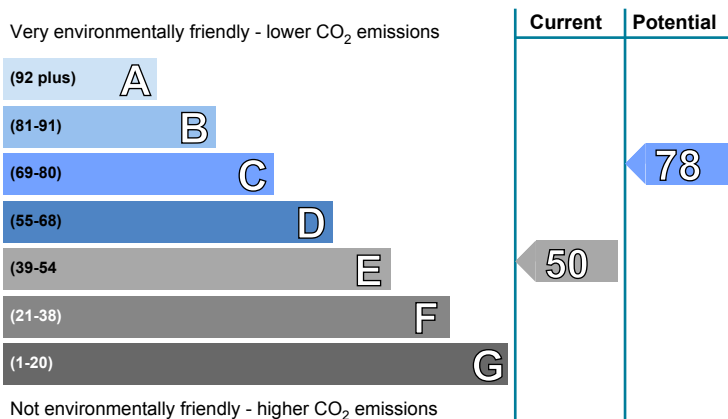
Environmental Impact (CO₂) Rating

This graph shows the effect of your home on the environment in terms of carbon dioxide (CO₂) emissions. The higher the rating, the less impact it has on the environment.
