YOUR ONESURVEY
HOME REPORT

28 Gilloch Avenue
Dumfries
DG1 4DN

SINGLE SURVEY

Single Survey

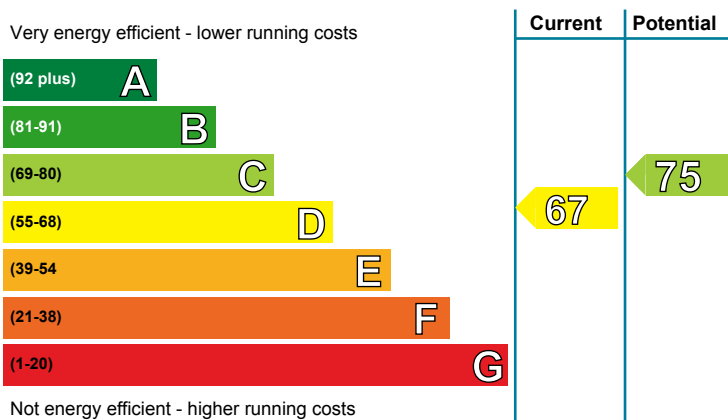
Energy Efficiency Rating

This graph shows the current efficiency of your home, taking into account both energy efficiency and fuel costs. The higher this rating, the lower your fuel bills are likely to be.

Your current rating is **band D (67)**. The average rating for EPCs in Scotland is **band D (61)**.

The potential rating shows the effect of undertaking all of the improvement measures listed within your recommendations report.
