# Home Report

# Scottish Single Survey

<b>Property address</b>	25 Glen Mark East Kilbride Glasgow G74 3UT
-------------------------	---

<b>Prepared by</b>	Shepherd Chartered Surveyors
--------------------	------------------------------

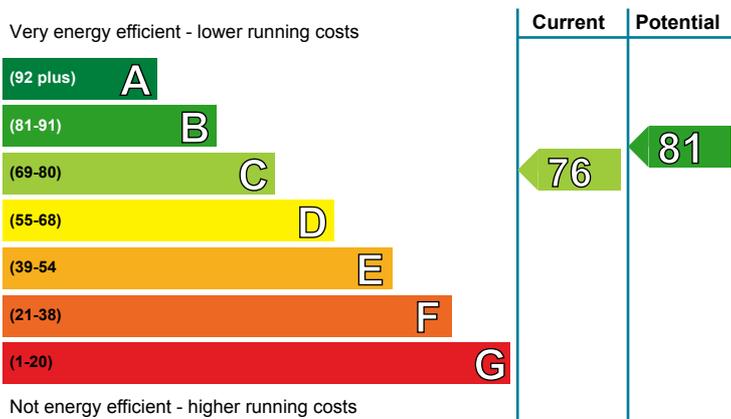
## Energy Efficiency Rating

This graph shows the current efficiency of your home, taking into account both energy efficiency and fuel costs. The higher this rating, the lower your fuel bills are likely to be.

Your current rating is **band C (76)**. The average rating for EPCs in Scotland is **band D (61)**.

The potential rating shows the effect of undertaking all of the improvement measures listed within your recommendations report.

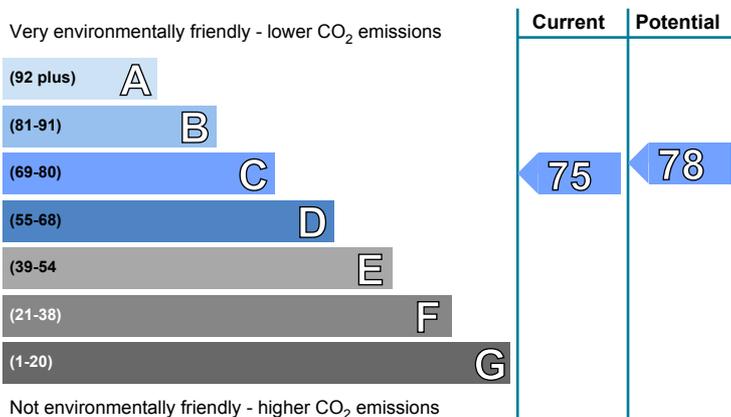
## Environmental Impact (CO<sub>2</sub>) Rating

This graph shows the effect of your home on the environment in terms of carbon dioxide (CO<sub>2</sub>) emissions. The higher the rating, the less impact it has on the environment.
