Home Report

Single Survey

Property address	73 Birch Road Cumbernauld Glasgow G67 3PE
Customer	
Customer address	63 Hopepark Drive Cumbernauld Glasgow G68 9FG
Prepared by	Shepherd Chartered Surveyors
Date of inspection	28/01/2026

Sectional Diagram showing elements of a typical house

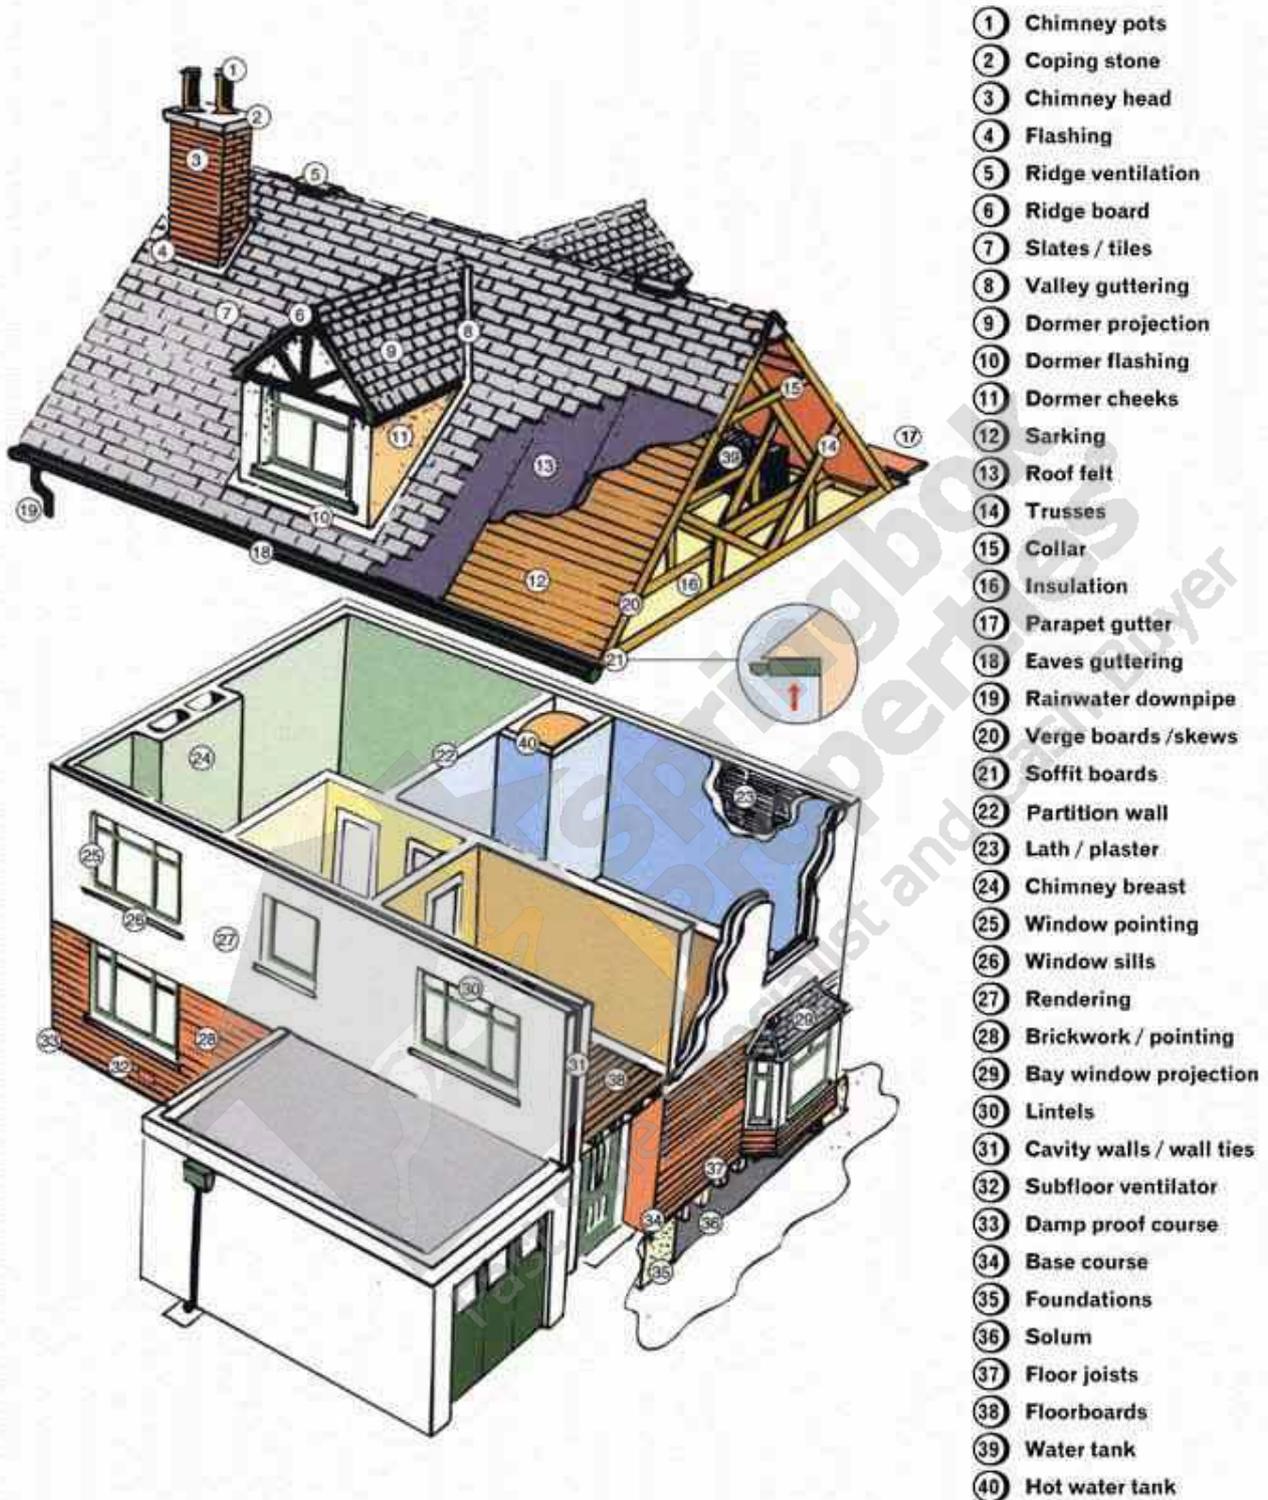
- ① Chimney pots
- ② Coping stone
- ③ Chimney head
- ④ Flashing
- ⑤ Ridge ventilation
- ⑥ Ridge board
- ⑦ Slates / tiles
- ⑧ Valley guttering
- ⑨ Dormer projection
- ⑩ Dormer flashing
- ⑪ Dormer cheeks
- ⑫ Sarking
- ⑬ Roof felt
- ⑭ Trusses
- ⑮ Collar
- ⑯ Insulation
- ⑰ Parapet gutter
- ⑱ Eaves guttering
- ⑲ Rainwater downpipe
- ⑳ Verge boards /skews
- ㉑ Soffit boards
- ㉒ Partition wall
- ㉓ Lath / plaster
- ㉔ Chimney breast
- ㉕ Window pointing
- ㉖ Window sills
- ㉗ Rendering
- ㉘ Brickwork / pointing
- ㉙ Bay window projection
- ㉚ Lintels
- ㉛ Cavity walls / wall ties
- ㉜ Subfloor ventilator
- ㉝ Damp proof course
- ㉞ Base course
- ㉟ Foundations
- ㊱ Solum
- ㊲ Floor joists
- ㊳ Floorboards
- ㊴ Water tank
- ㊵ Hot water tank

Reference may be made in this report to some or all of the above component parts of the property. This diagram may assist you in locating and understanding these items.

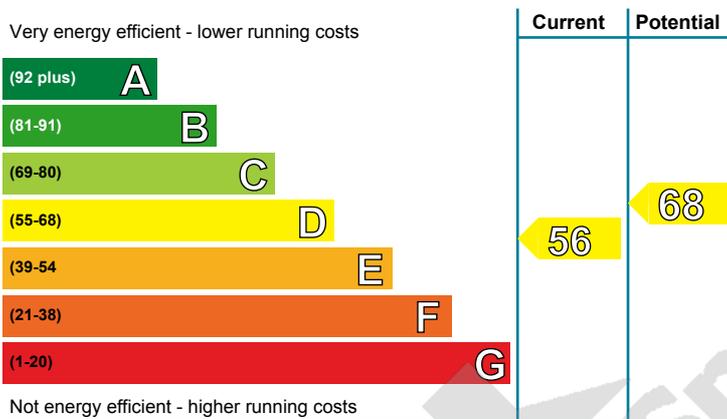
Energy Efficiency Rating

This graph shows the current efficiency of your home, taking into account both energy efficiency and fuel costs. The higher this rating, the lower your fuel bills are likely to be.

Your current rating is **band D (56)**. The average rating for EPCs in Scotland is **band D (61)**.

The potential rating shows the effect of undertaking all of the improvement measures listed within your recommendations report.

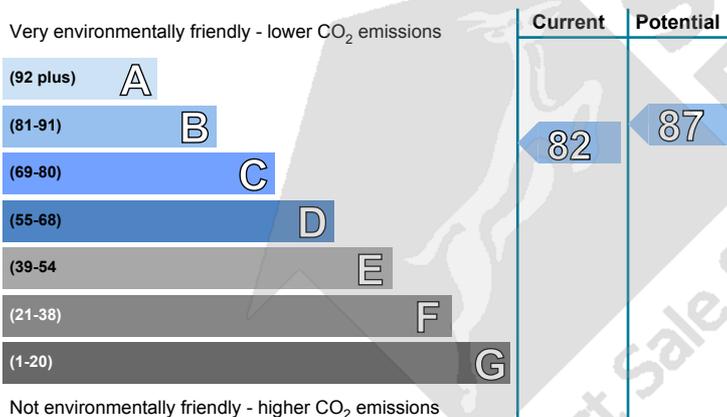
Environmental Impact (CO₂) Rating

This graph shows the effect of your home on the environment in terms of carbon dioxide (CO₂) emissions. The higher the rating, the less impact it has on the environment.
