# Home Report

9 Morar Place  
Broughty Ferry Dundee DD5 3HL

# Single Survey

<b>Property Address</b>	9 Morar Place Broughty Ferry Dundee DD5 3HL
<b>Customer</b>	Karen McRobbie (as Executor)
<b>Prepared by</b>	Graham + Sibbald Property Consultants Limited
<b>Date of Inspection</b>	13/05/2026

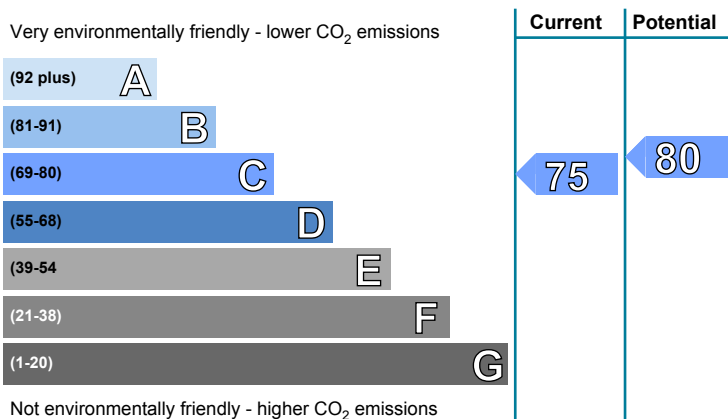
## Environmental Impact (CO<sub>2</sub>) Rating

This graph shows the effect of your home on the environment in terms of carbon dioxide (CO<sub>2</sub>) emissions. The higher the rating, the less impact it has on the environment.
