# Home Report

# Scottish Single Survey

<b>Property address</b>	Eilean Fraoich North Connel Oban PA37 1QX
<b>Customer</b>	John Stone
<b>Customer address</b>	Eilean Fraoich North Connel Oban PA37 1QX
<b>Prepared by</b>	Shepherd Chartered Surveyors
<b>Date of inspection</b>	19/03/2026

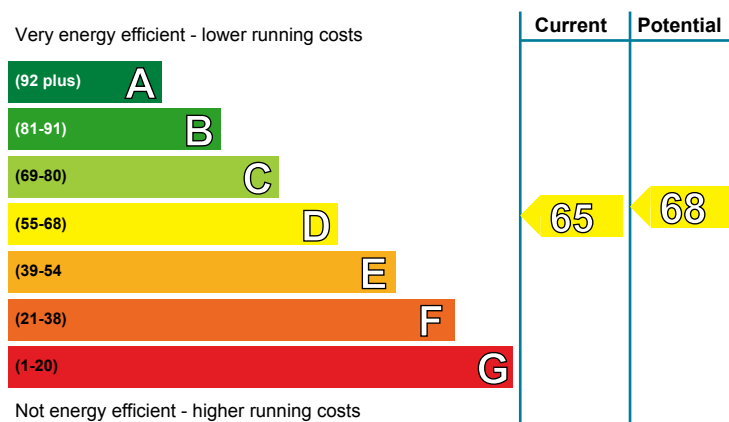
## Energy Efficiency Rating

This graph shows the current efficiency of your home, taking into account both energy efficiency and fuel costs. The higher this rating, the lower your fuel bills are likely to be.

Your current rating is **band D (65)**. The average rating for EPCs in Scotland is **band D (61)**.

The potential rating shows the effect of undertaking all of the improvement measures listed within your recommendations report.

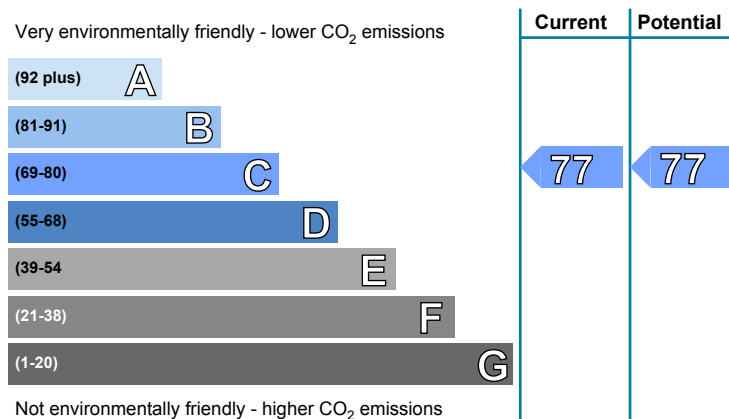
## Environmental Impact (CO<sub>2</sub>) Rating

This graph shows the effect of your home on the environment in terms of carbon dioxide (CO<sub>2</sub>) emissions. The higher the rating, the less impact it has on the environment.
