Single Survey

Property address	Old Fetternear School, Fetternear, Inverurie, AB51 5JY
-------------------------	---

Prepared by	Allied Surveyors Scotland Ltd
--------------------	-------------------------------

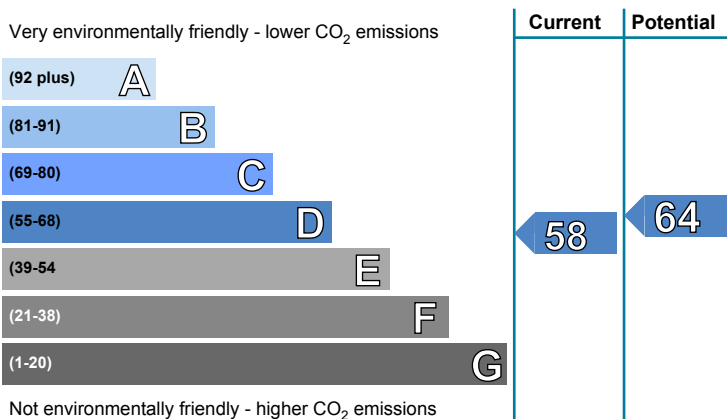
Environmental Impact (CO₂) Rating

This graph shows the effect of your home on the environment in terms of carbon dioxide (CO₂) emissions. The higher the rating, the less impact it has on the environment.

The potential rating shows the effect of undertaking all of the improvement measures listed within your recommendations report.

The average Scottish household produces about 6 tonnes of carbon dioxide every year. Based on this assessment, heating and lighting this home currently produces approximately 9.5 tonnes of carbon dioxide every year. Adopting recommendations in this report can reduce emissions and protect the environment. If you were to install all of these recommendations this could reduce emissions by 1.2 tonnes per year. You could reduce emissions even more by switching to renewable energy sources.
