77 Western Road,
Aberdeen,
AB24 4DR

Home Report

Single Survey

Survey Report on:

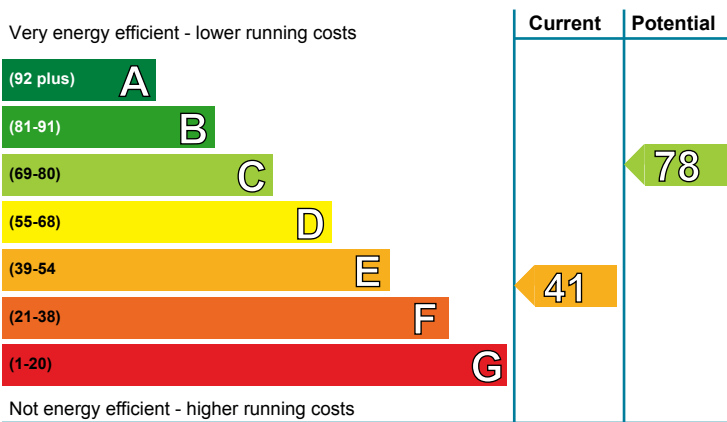
Energy Efficiency Rating

This graph shows the current efficiency of your home, taking into account both energy efficiency and fuel costs. The higher this rating, the lower your fuel bills are likely to be.

Your current rating is **band E (41)**. The average rating for EPCs in Scotland is **band D (61)**.

The potential rating shows the effect of undertaking all of the improvement measures listed within your recommendations report.
